Recovery from the great earthquake in 2011 and a radioactive material leak incident at J-PARC in 2013

Kotaro BESSHO
Safety Division, J-PARC Center

- ◆ **The Great East Japan Earthquake on March 11, 2011.**
- ◆ **Radioactive material leak incident at the J-PARC Hadron Experimental Facility on May 23, 2013.**

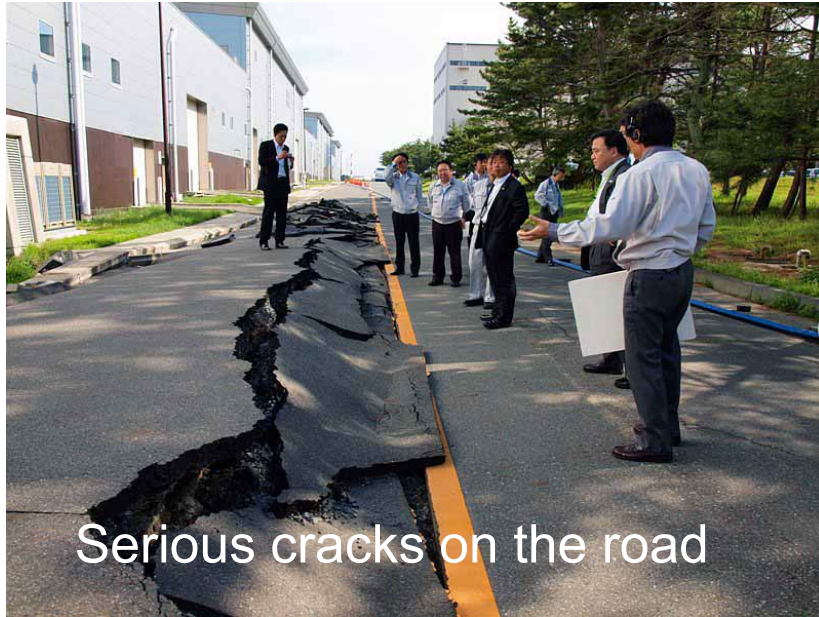
Outside LINAC main building

Serious cracks on the road

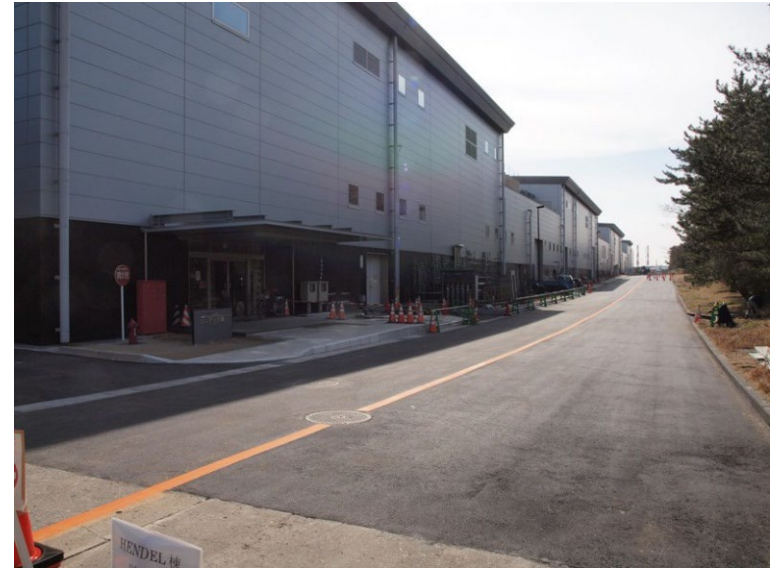
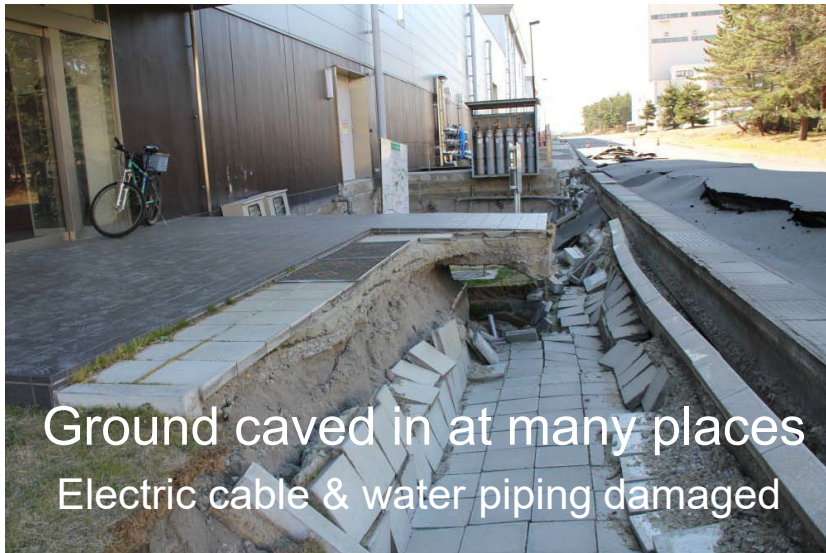
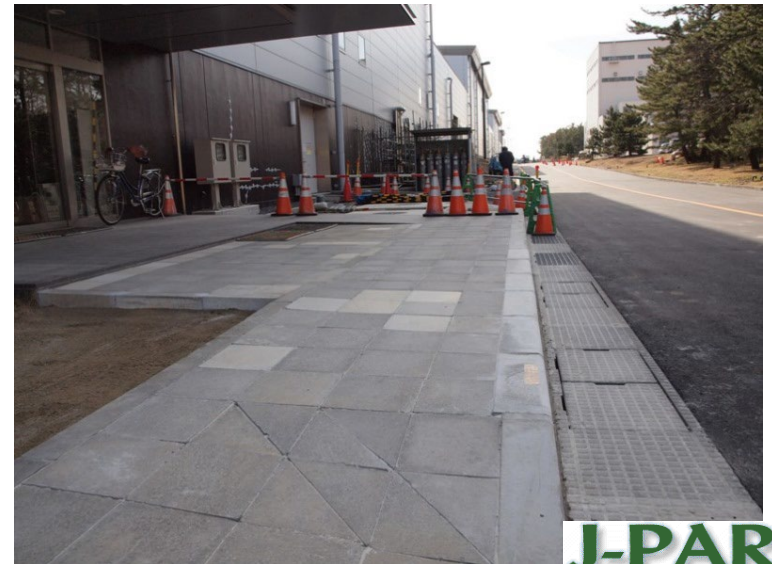
Ground caved in at many places
Electric cable & water piping damaged

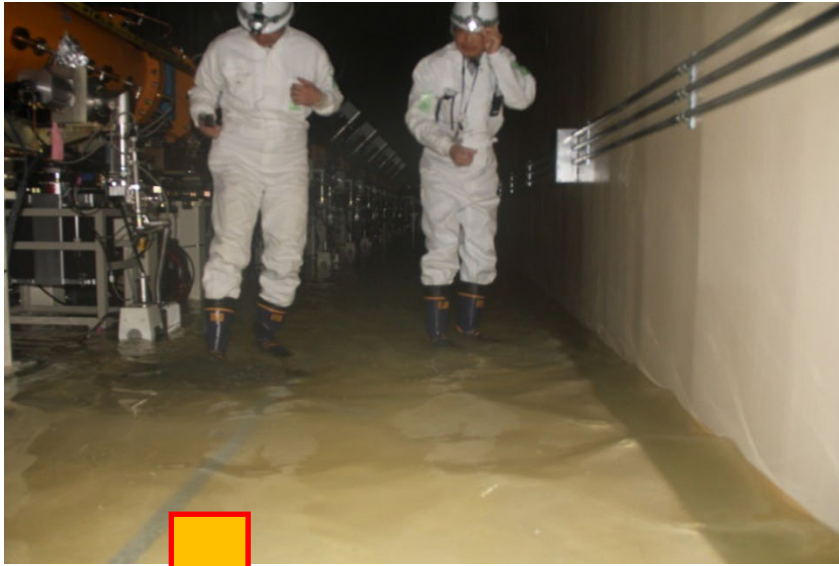
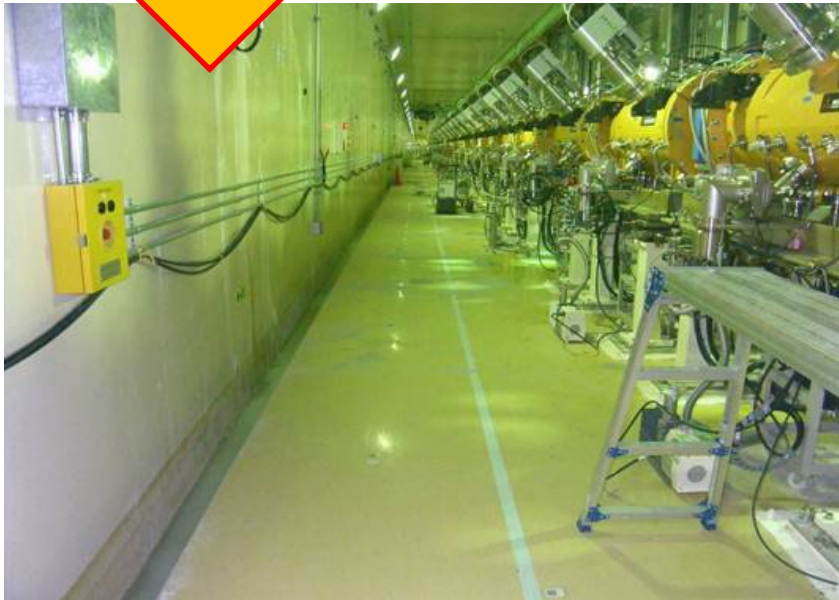
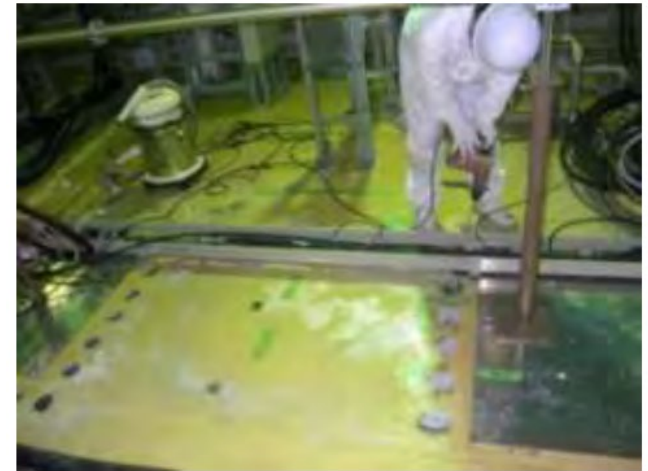
Inside LINAC tunnel

LINAC tunnel : 15 m underground

Groundwater slowly flew into the tunnel. (~10 cm / ~100 tons).

- Draining water
- Waterproofing repairs

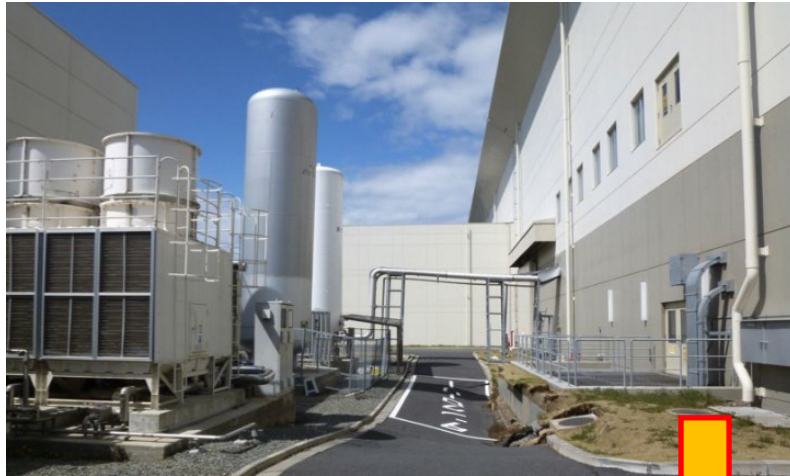
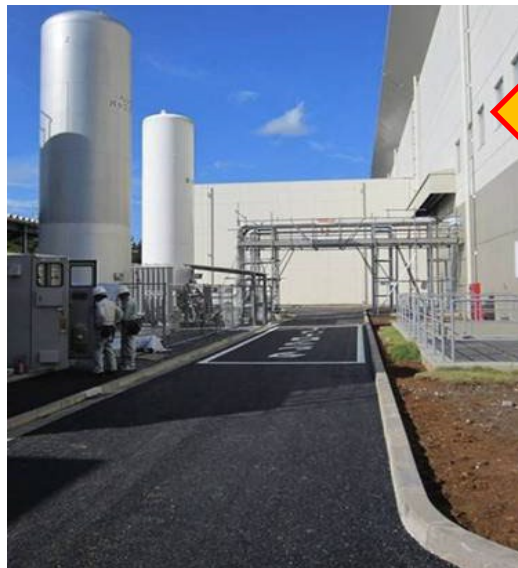
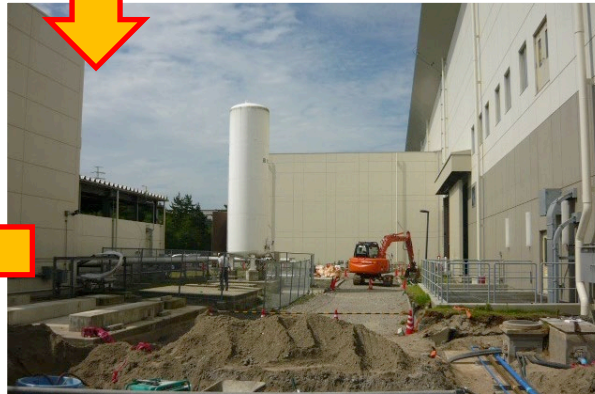
Outside MLF main building

Ground damaged
Units tilted, damaged

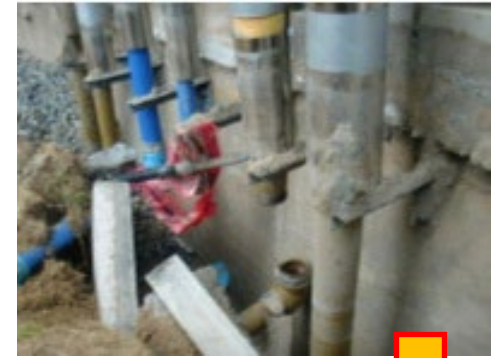
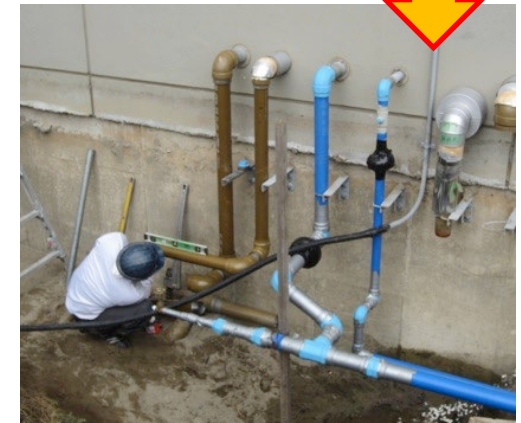
Water/gas pipes broken

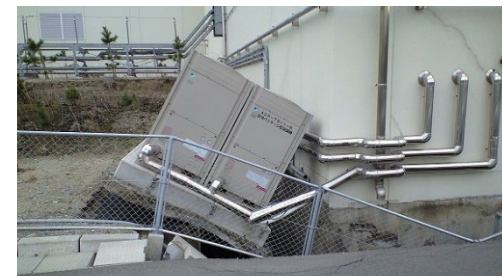
At NU facility

Outdoor units
damaged

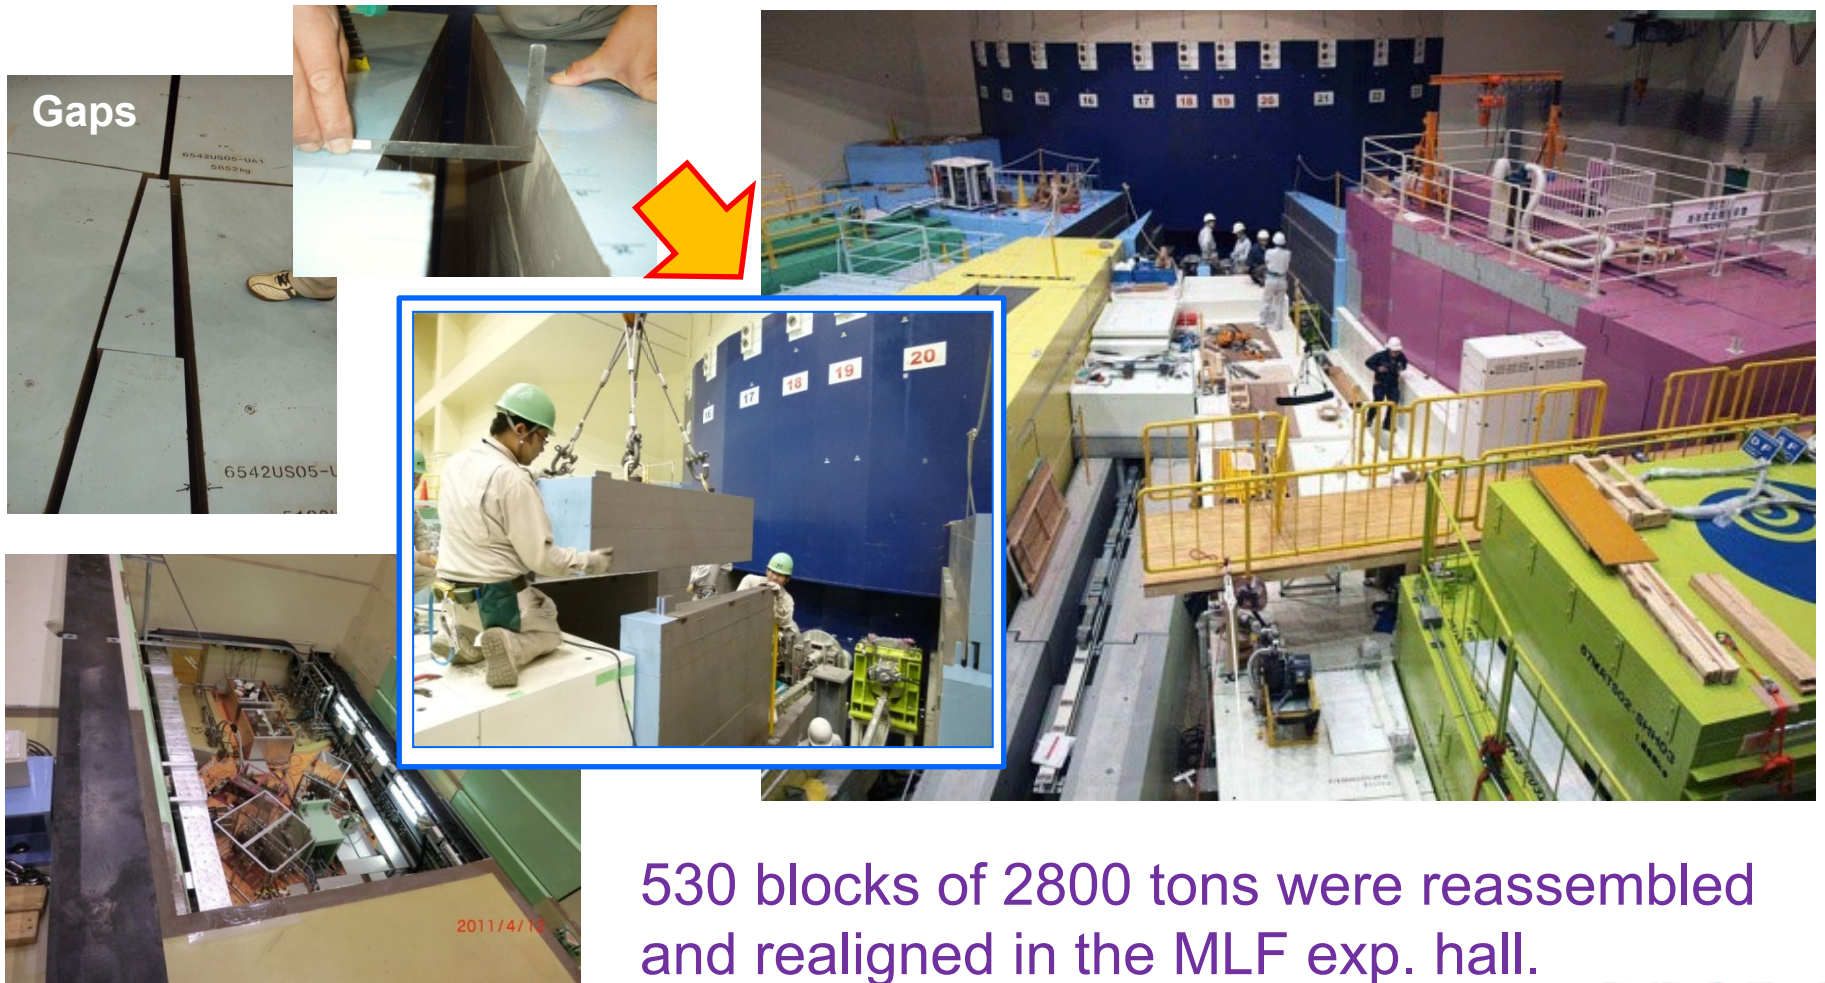
Inside MLF experimental hall

No obvious damage to main buildings
Concrete shielding blocks moved by large shaking

530 blocks of 2800 tons were reassembled and realigned in the MLF exp. hall.

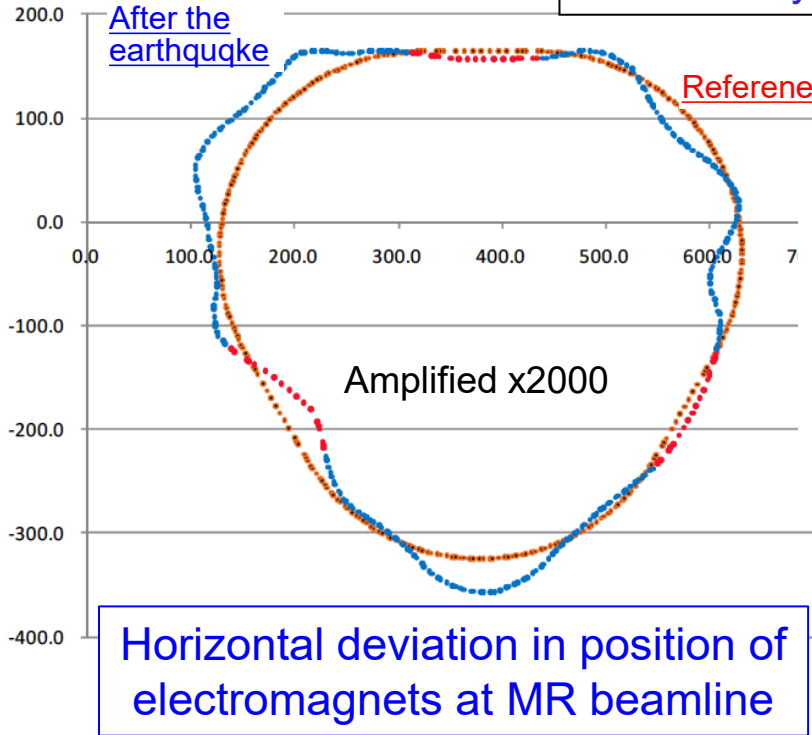
Immediately after the earthquake

Misalignment of electromagnets at accelerator and beamline

misaligned ~ 20 mm (horizontal)
~ 8 mm (vertical)
for 400 electromagnets

Adjusted to
within 0.4 mm deviation

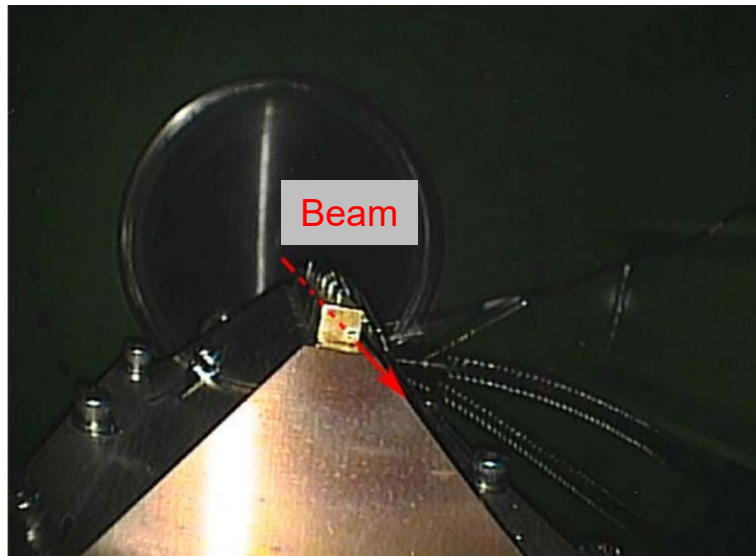
Gold target viewed from downstream side of the proton beam

- ◆ ~ 1 mm hole was observed.

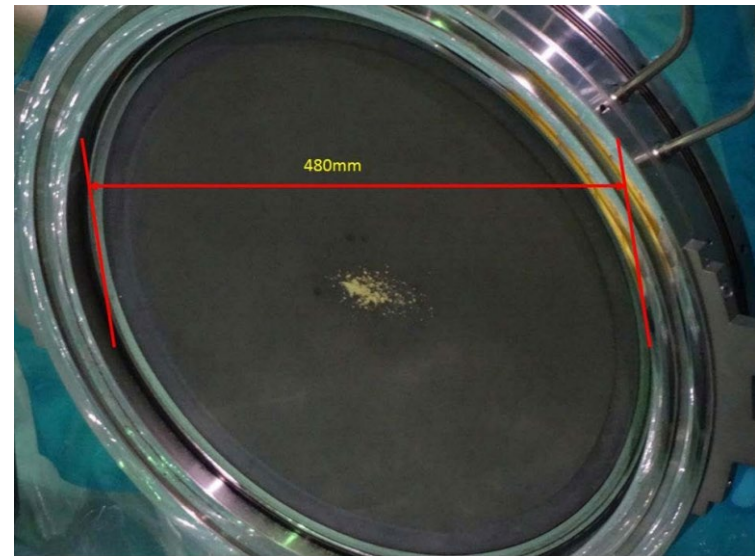
Beam window behind the gold target

- ◆ Gold splash was scattered on the beam window towards the beam direction.

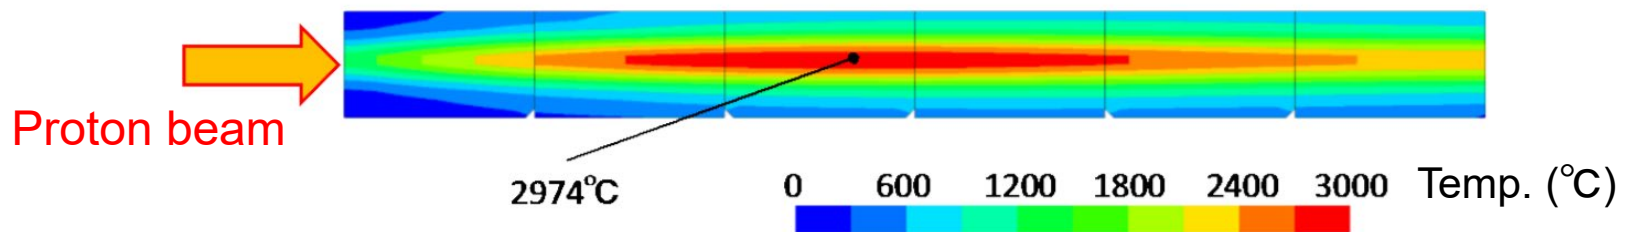
Calculated temperature profile immediately after the abnormal shot.

Gold (Au) melting point : 1064°C, boiling point : 2856°C

Au ⇒ liquid, gas
