# **Experience with machine protection system at J-PARC**

**N. Hayashi**

**October 11, 2022**

**ESS - J-PARC commissioning workshop**

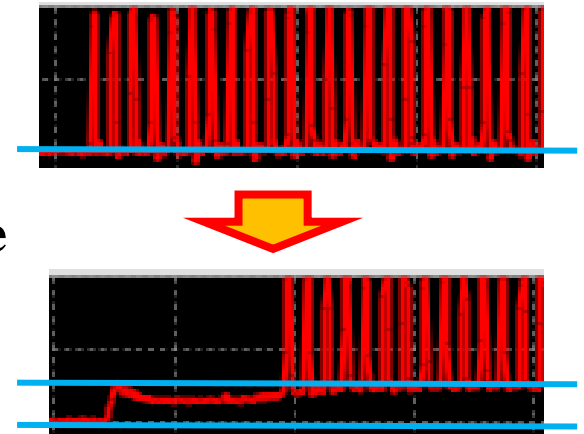
# Chopper malfunction

- **2015/11 (November, 2015) and sometimes**
  - **Fact:** Twice intensive beam ( $8E+13$ ) than intended ( $4.3E+13$ )
  - **Cause:** missing trigger pulse (due to O/E module)
  - **1-shot MPS:** “num. of particles limiter for one pulse”
- **2016/6/29 (29 June, 2016)**
  - **Beam current pattern by CT**
    - Normal (up) , MPS event (down)
  - Normally the pattern is exact comb shape
  - MPS events shows some residual beam
    - It is due to chopper malfunction
  - No beam loss in the linac
  - But heavy beam loss in the RCS
  - Root cause is timing module problem

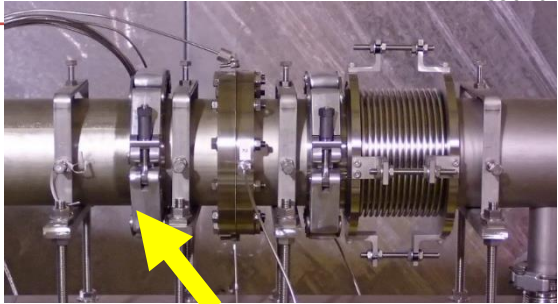
**Beam window (0.36mm Ni)**  
To separate vacuum  $10^{-7}$  and  $10$  pa

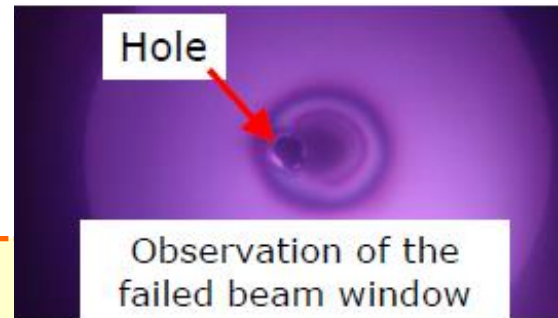
Hole  
Observation of the failed beam window

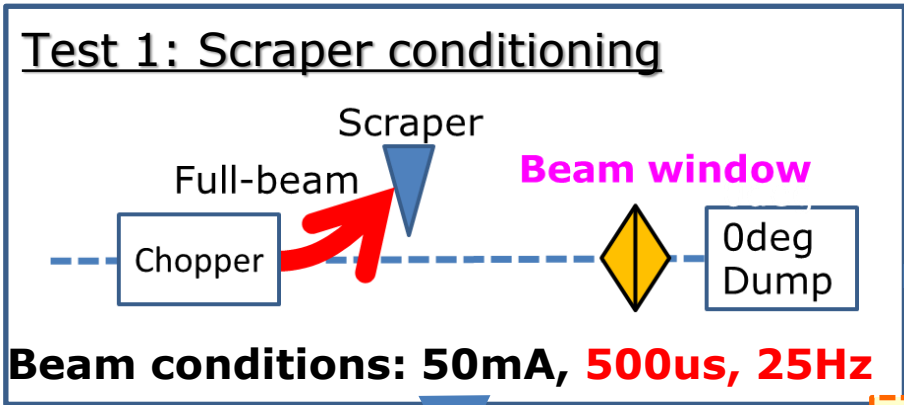
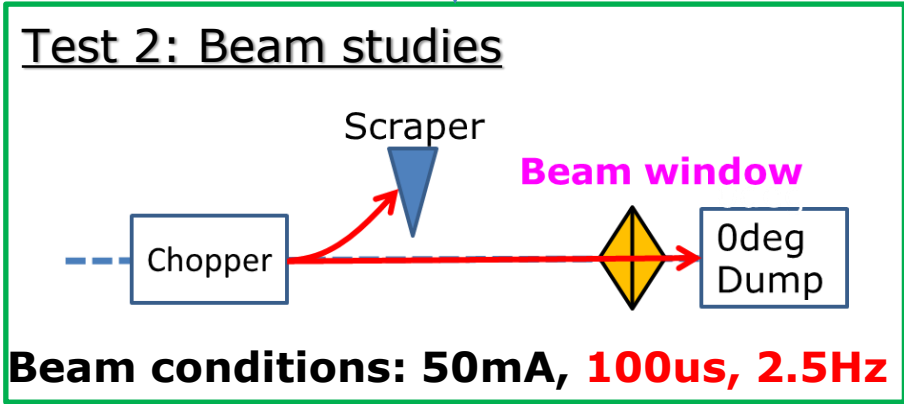
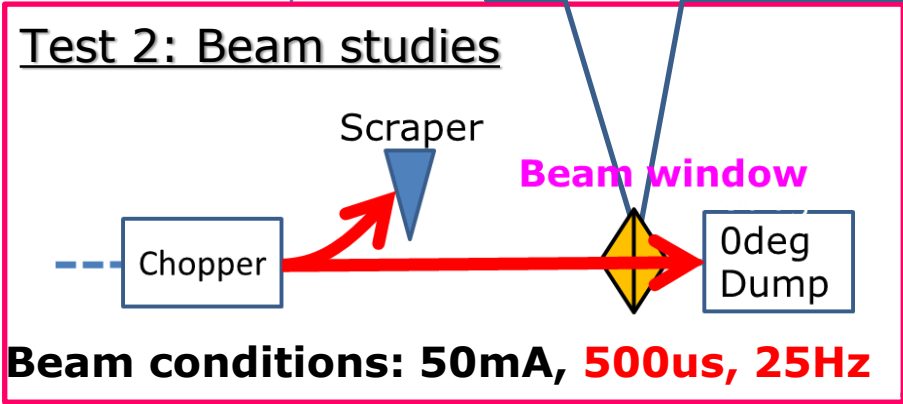
(Oct. 13<sup>th</sup>, 2018)

**Beam stop:**  
500us -> 100us, 25Hz -> 2.5Hz

Beam stop <- "Skip"  
(Human error)

**Destruction**  
(estimated temp.:  
~1,500°C after 1s)

- **Full beam (50mA, 500us, 25Hz) irradiated the window for six seconds**
- **Human error (?) (not following ordinary procedure)**
- **(BLM threshold was appropriate level...?)**

- **One second integral num. of particle limiter**
