CRITICAL DESIGN REVIEW FOR THE WELDS OF PORT TUBES ON MONOLITH VESSEL

F. Sordo¹, on behalf of ESS-Bilbao team, AVS and Cadinox teams.

Consorcio ESS-BILBAO, AVS and CADINOX

March 15th, 2021

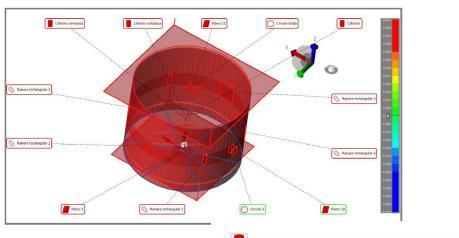
Dimensional control previous to pressure test (Mar 6th, 2020)

The intermediate metrology shows deformations above the expected values in the windows frame. However, there is still large amount of extra material for final machining.

Cilindro soladura Lectures: 108							
		real	nominal	Desv	- tol.	+tol.	FueraTol
Diámetro		5.390,943mm			-0.050mm	0,050mm	
Cilindricidad	N	15.079mm		15,079mm	0.000mm	0.050mm	15.029mm

Cilindro							Lectures:80
		real	nominal	Desv	- tol.	+tol.	FueraTol
Diámetro		5.396,545mm			-0.050mm	0.050mm	
Cilindricidad	N	16,547mm		16,547mm	0.000mm	0,050mm	16,497mm

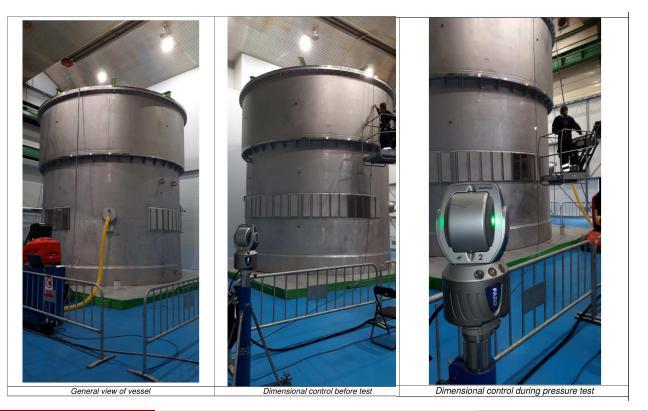
Pressure test completed on April 29th, 2020

Pressure test completed without incidences. Pre and post test metrology shows only elastic deformation during the test as it was expected.

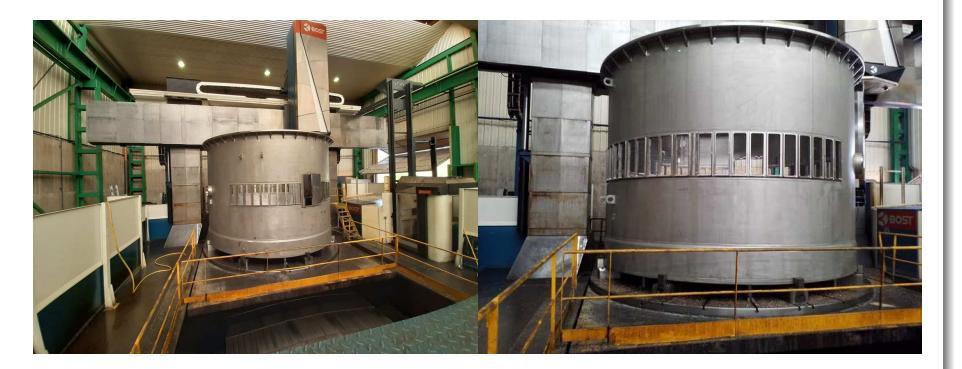
Inspection visits on July 2020.

After several clarification work in the functional tolerances of the windows the machine work restarted on June 2020. On August 4^th , 2020 the manufactured reported "instability in the vessel". The machining velocity was reduced to 1/3 of the previous speed.

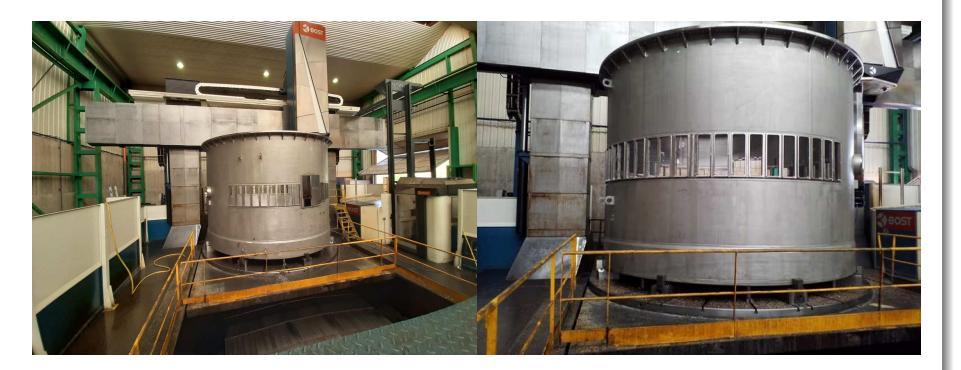
Inspection visits on July 2020.

After several clarification work in the functional tolerances of the windows the machine work restarted on July 2020. On August 4^th , 2020 the manufactured reported "instability in the vessel". The machining velocity was reduced to 1/3 of the previous speed.

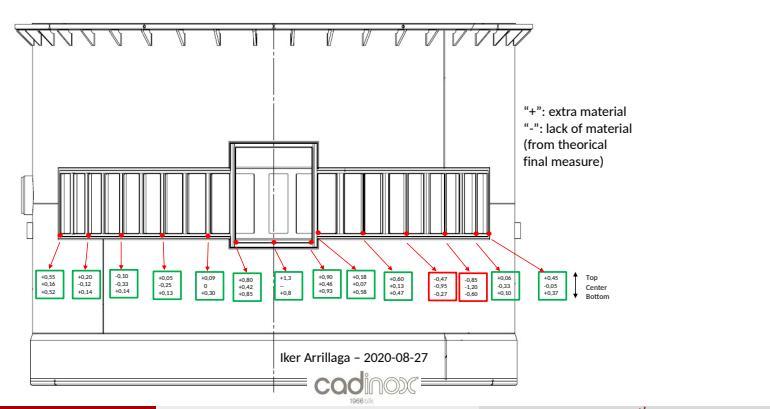
August 28^t h dimensional control

After the 15 days August closure, the manufactured reported changes in the geometry compared with dimensional control performed after the 2^{nd} machining step.

- Completely unexpected distortion once material is removed from Windows. Pattern of "snake": out in the middle, inside in "1/4" and "3/4" and guite correct in extremities.
- Distance "L" cannot be respected is some Windows (highlighted in red)
- Distance "L" will be final machined to respect dimension in the rest of the Windows as planned (highlighted in green)
- Bottom surfaces and upper flange verified and no distortion.
- First and main hypothesis of root cause (TBC):
 - References and CAD-CAM machining program are correct
 - During 15 days, rested in the vertical lathe, unclumped. Possible "natural" stress relieve and distortion. Temperature range changing from 15°C-35°C.

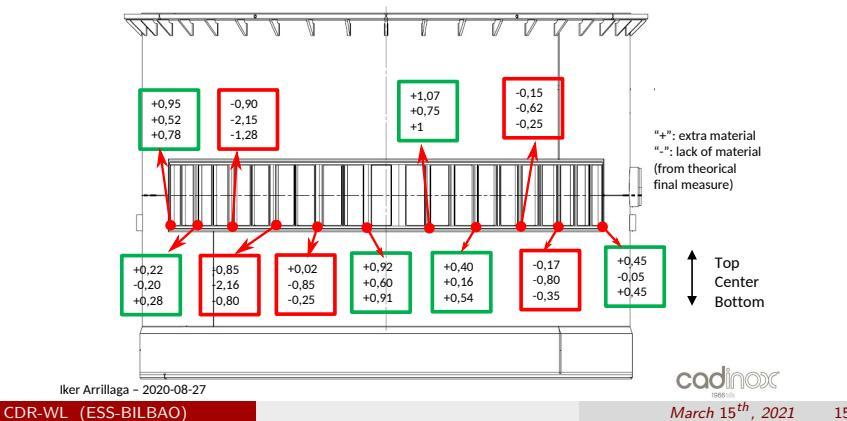
August 28^t h dimensional control

After the 15 days August closure, the manufactured reported changes in the geometry compared with dimensional control performed after the 2^{nd} machining step.

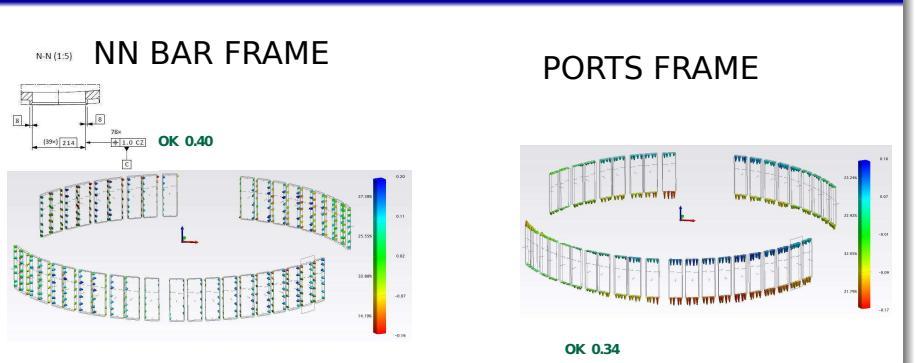
FAT metrology report

The incidence was evaluated with ESS and the deviations in "L" distance can be compensated adjusting the length of the port tubes. The final tolerances of the vessel shows fluctuations in the position of the welding plane and good shape tolerances of the bevel lated to the center of the welding plane.

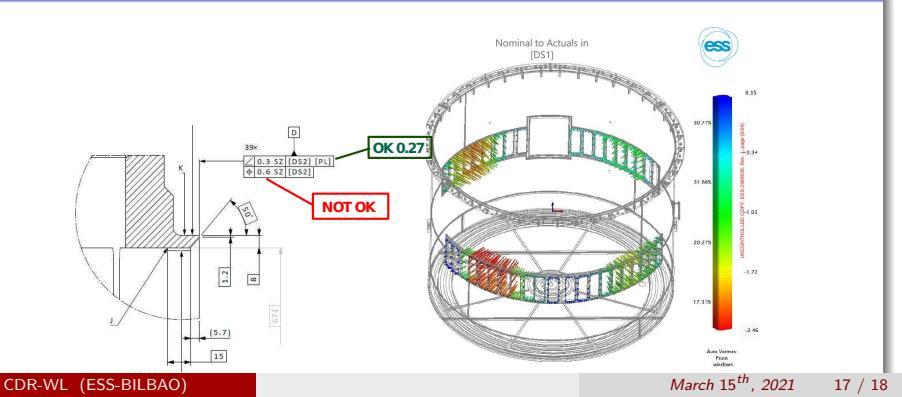
FAT metrology report

The incidence was evaluated with ESS and the deviations in "L" distance can be compensated adjusting the length of the port tubes. The final tolerances of the vessel shows fluctuations in the position of the welding plane and good shape tolerances of the bevel lated to the center of the welding plane.
