Solaris Commissioning

Carlo J. Bocchetta

Solaris Project Overview

SOLARIS
NATIONAL SYNCHROTRON
RADIATION CENTRE

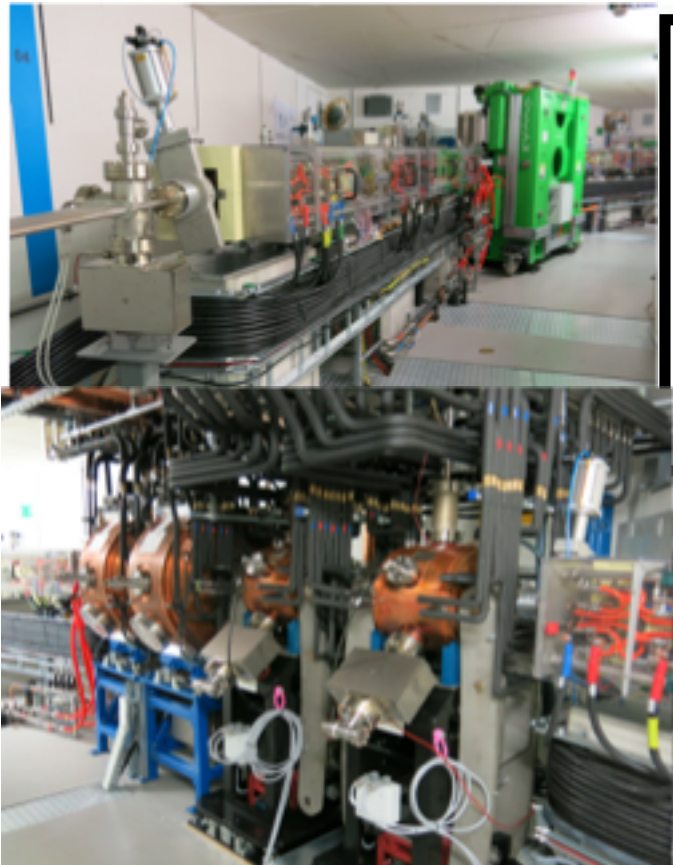
1.5GeV Storage ring
12 DBA Cells – 96 m circ.
Space for ID's (10 sections) ~ 3.5 m
10 straight sections for Ids
100 MHz RF system
300 MHz Landau Cavities
Injection dipole kicker
Ramping
In operation since May 2015

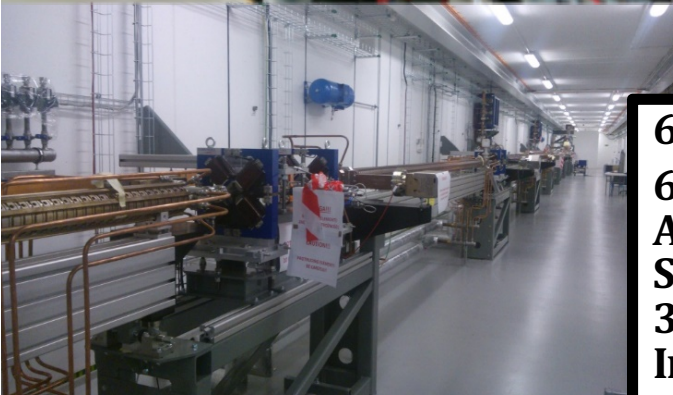
600 MeV Linac with RF Thermionic Gun
6 accelerating structures combined in 3 units
Accelerating gradient 20 MeV/m
S-band – 2998.5 MHz
3 RF Units & SLED cavities
In operation since Dec. 2014

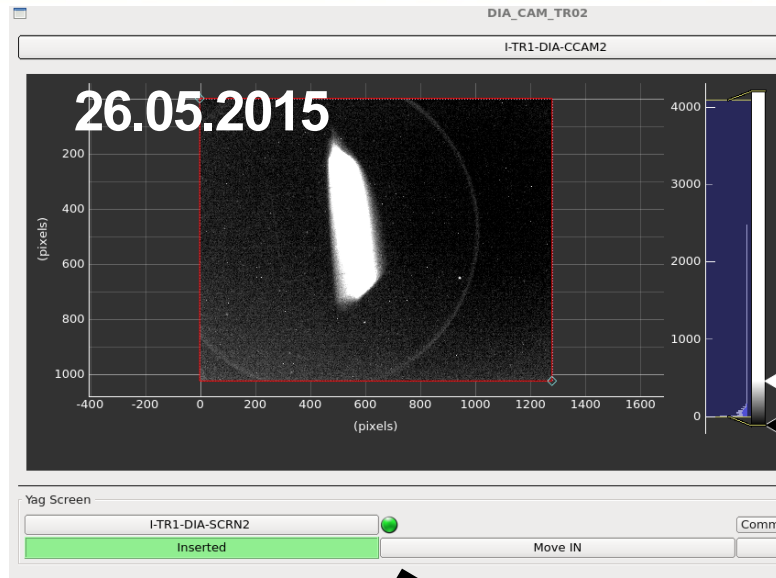
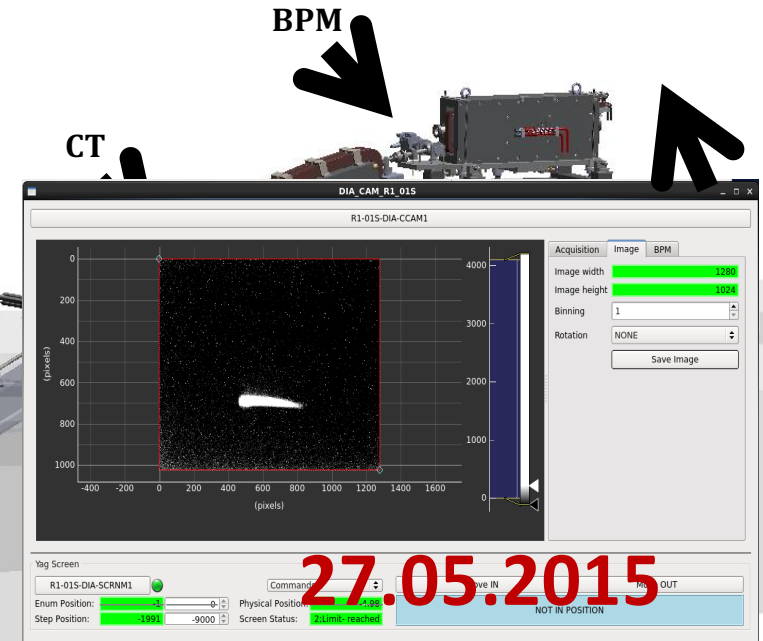
Beam in the storage ring
Energy 320 MeV
Charge 1.5 nC
rep rate 10Hz

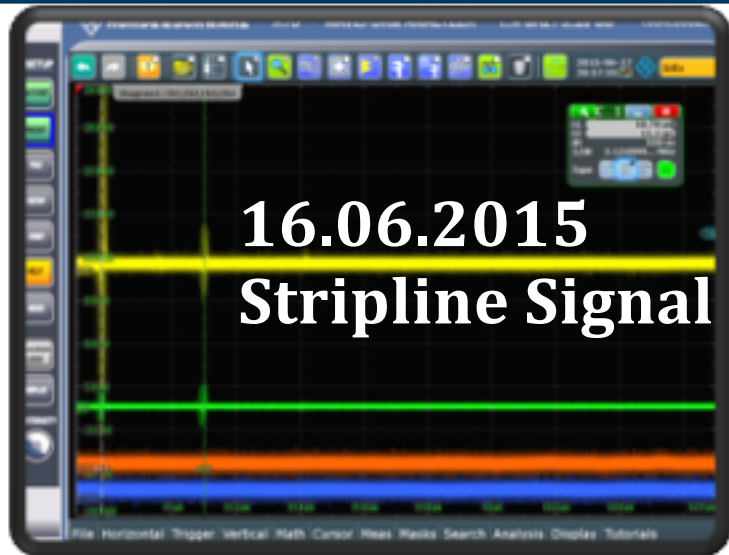
2 turns (2 yellow peaks 320 ns apart) was observed

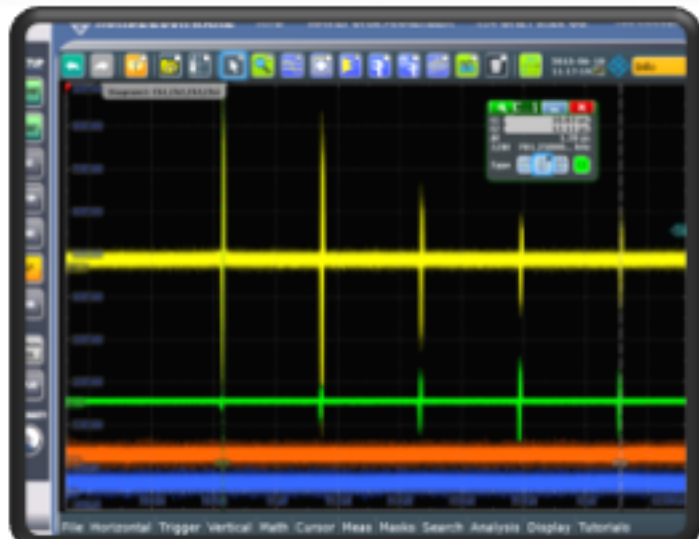
11.06.2015 - First turn

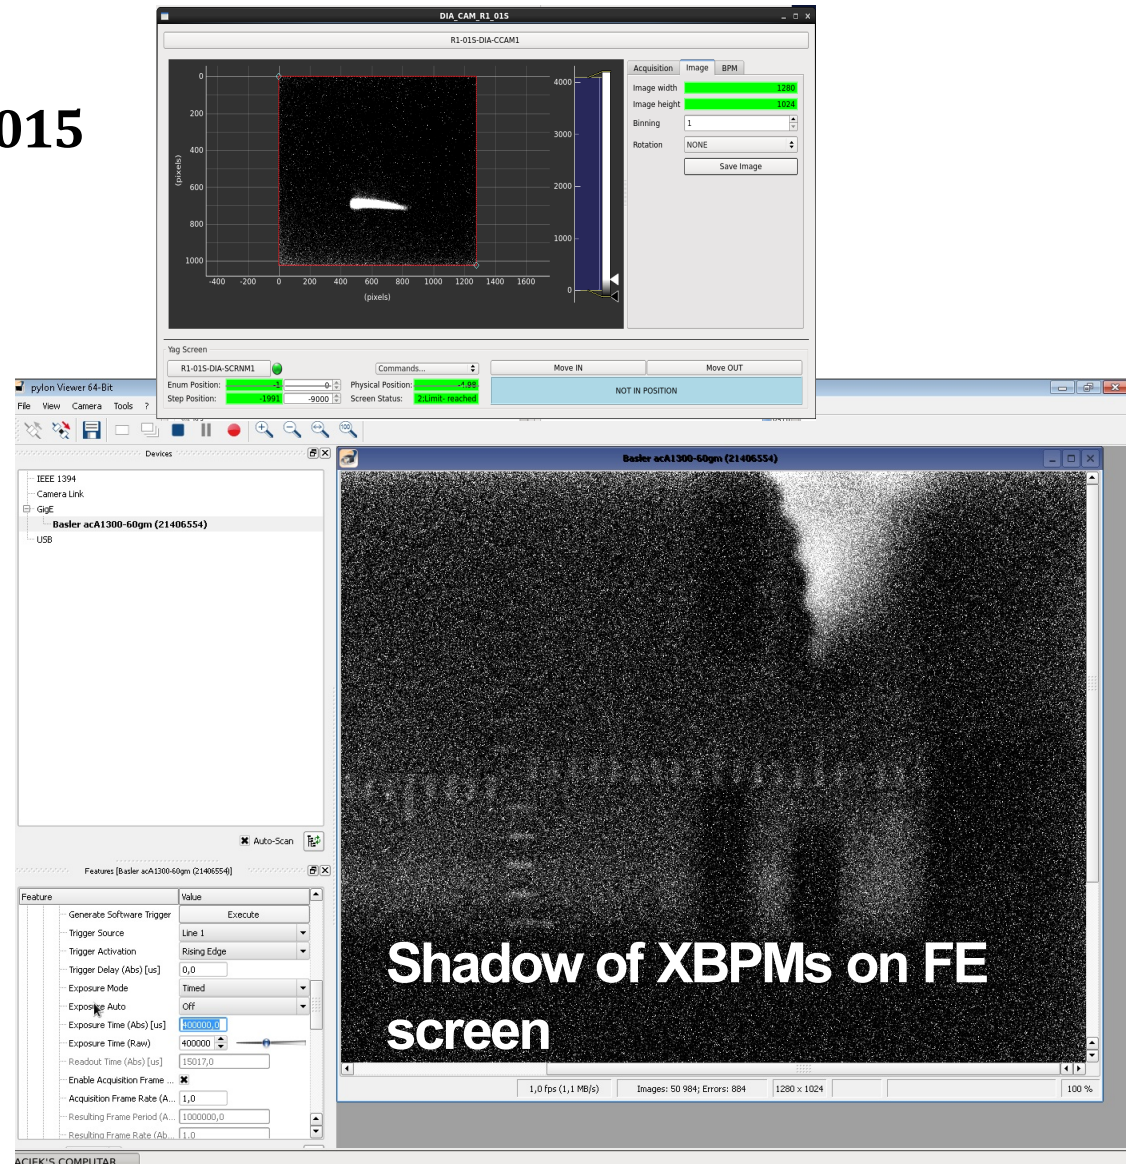
**Shadow of XBPMs on FE
screen**

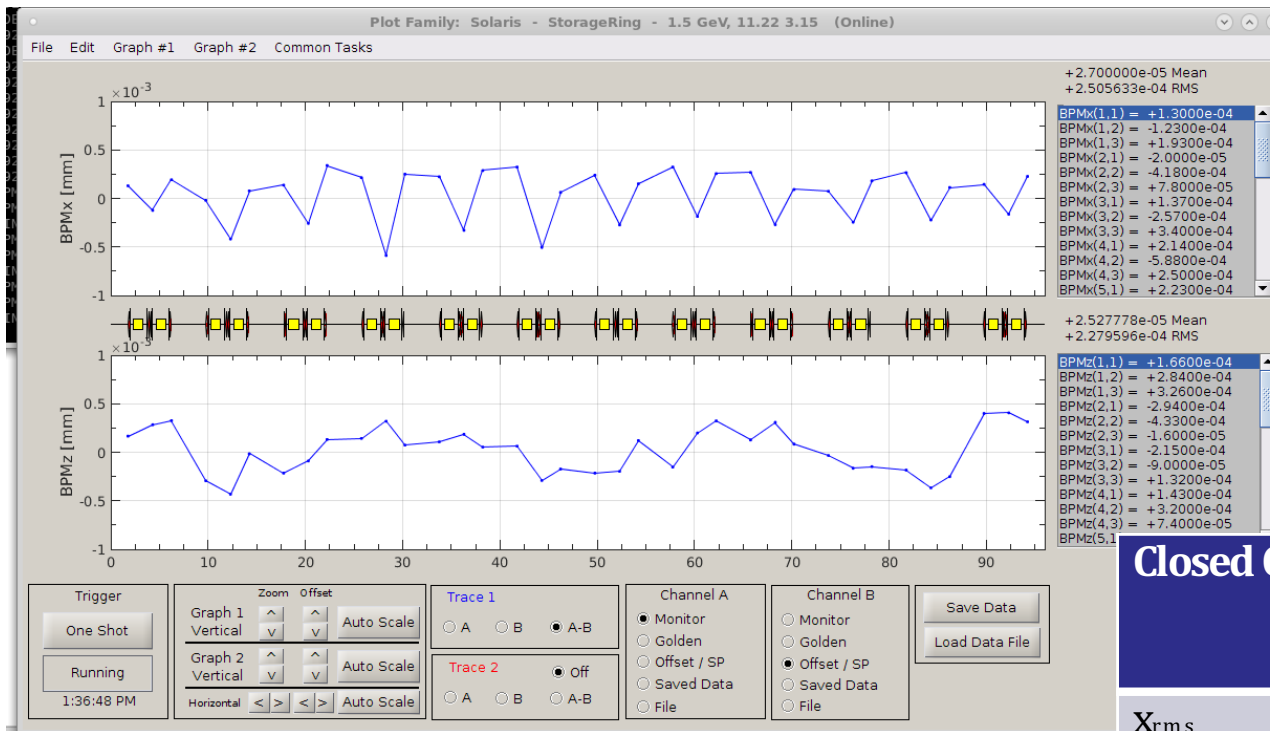
Closed Orbit	With correction & BBA before	With correction & BBA After
x_{rms}		160 μm	0.25 μm
y_{rms}		55 μm	0.22 μm

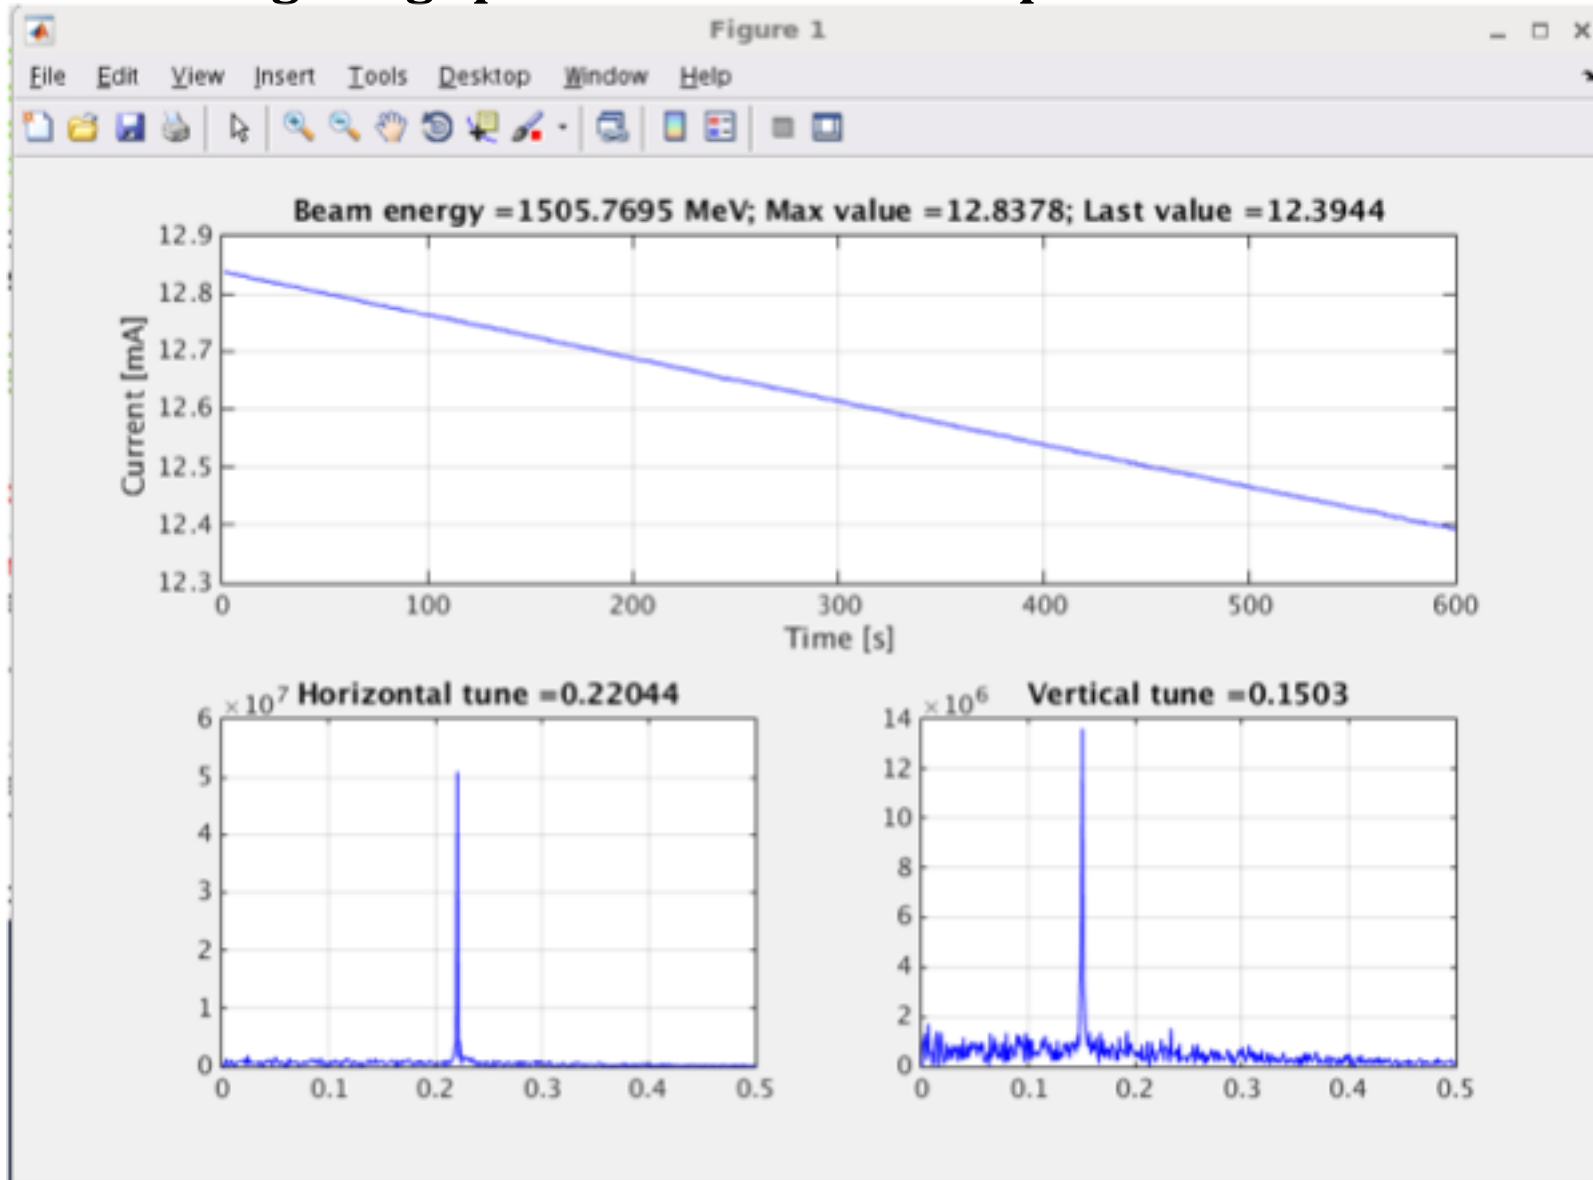
The storage ring operates at its nominal optics.

$Q_x=0.22044$

$Q_y=0.1503$

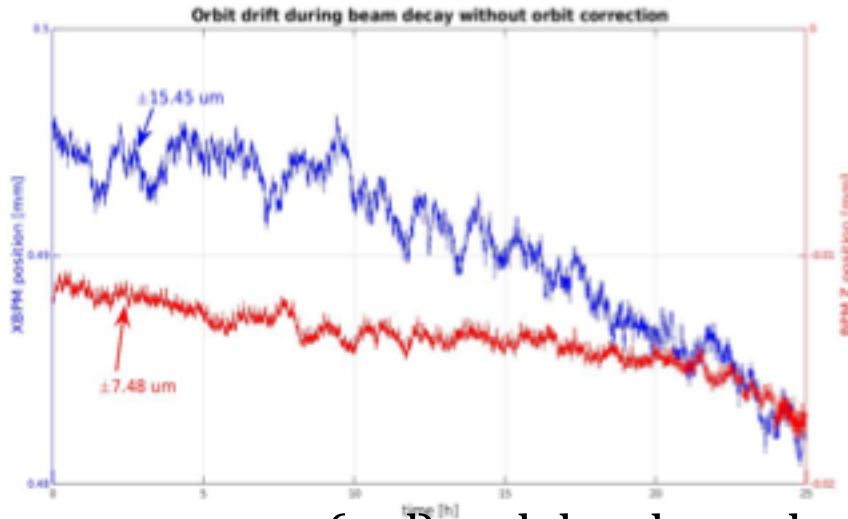
The vertical position drift of electron (red) and photon (blue) beam monitored over 25h without orbit correction.

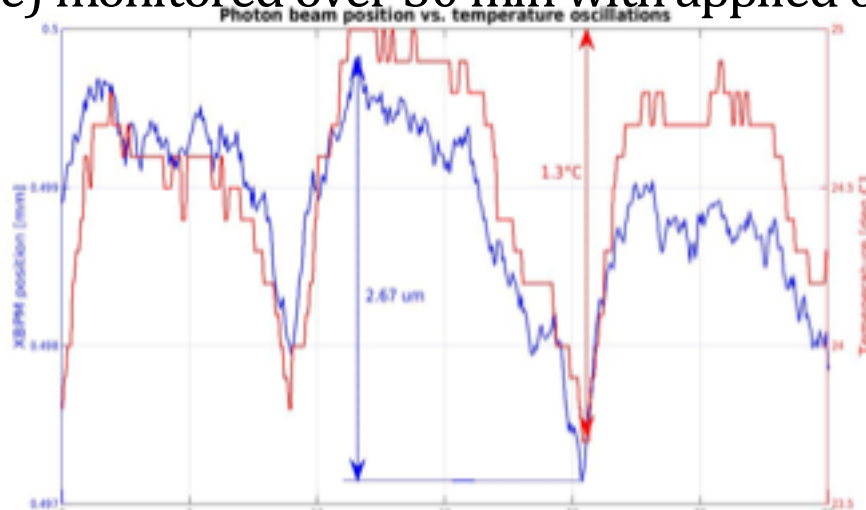
Temperature oscillations in the range of 1.5-2.0 °C in the storage ring have impact on beam stability.

The temperature (red) and the photon beam oscillations (blue) monitored over 30 min with applied orbit correction.

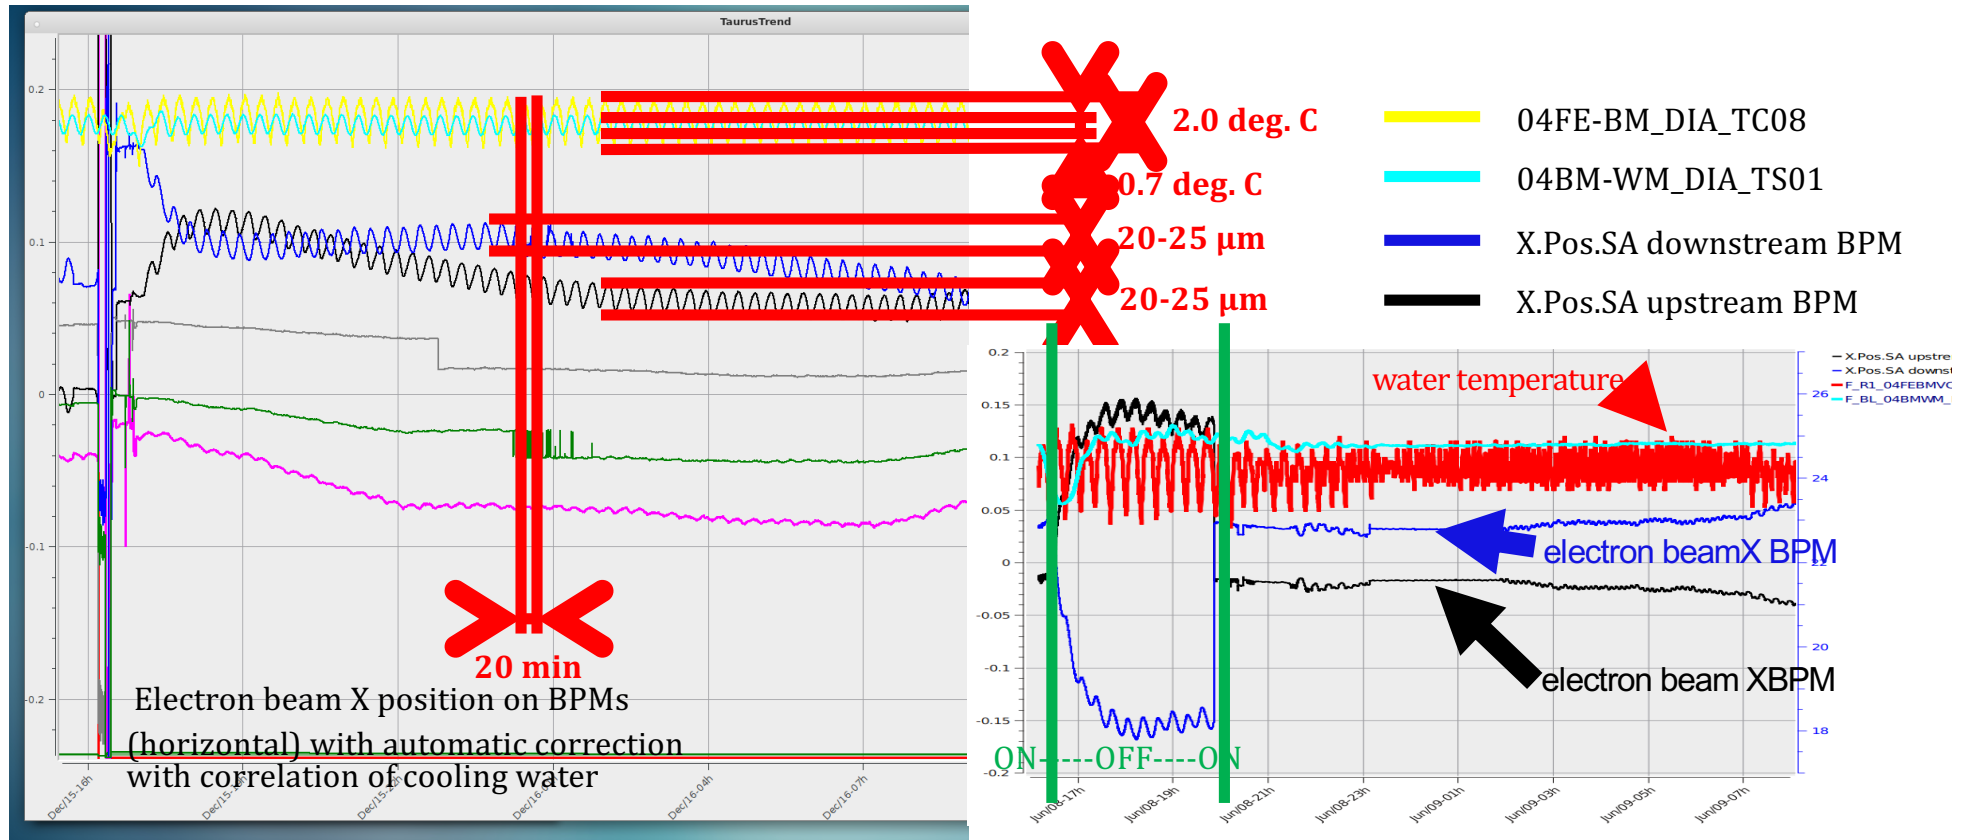
- Amplitude of vibration
 - with no automatic correction: **20-25 μm**
 - with automatic correction: **8-15 μm**
- Oscillation period: **20 min**
- Place of measurement: **BPMs & XBPMs**

The direct cause of the oscillation of the electron beam and the photon beam in the Storage Ring is the oscillation of the cooling water temperature in main backbone.

Time period: 16 h, correction ON-OFF-ON

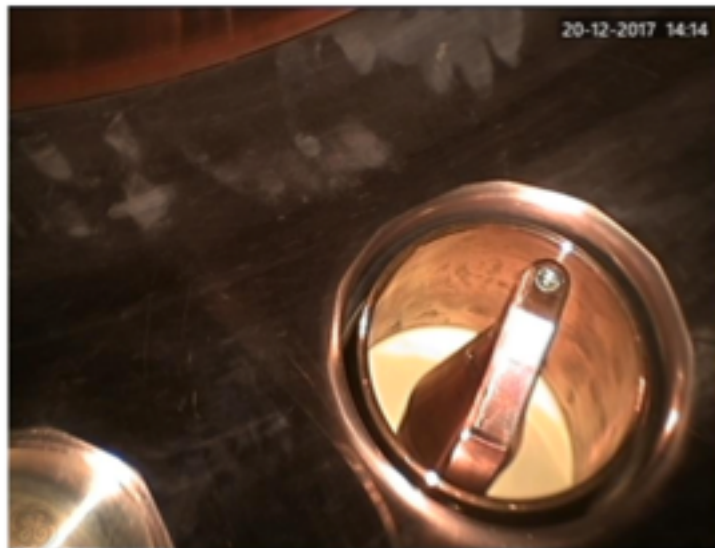
100MHz CAV1, shell

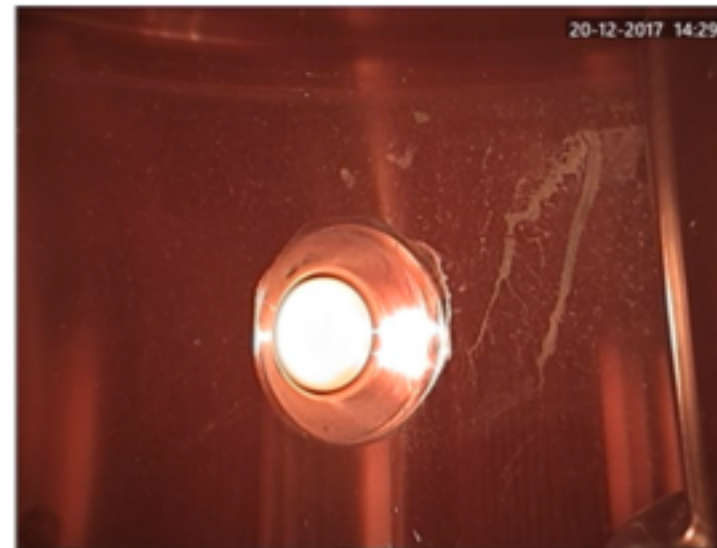
300MHz LAN2, bottom pickup

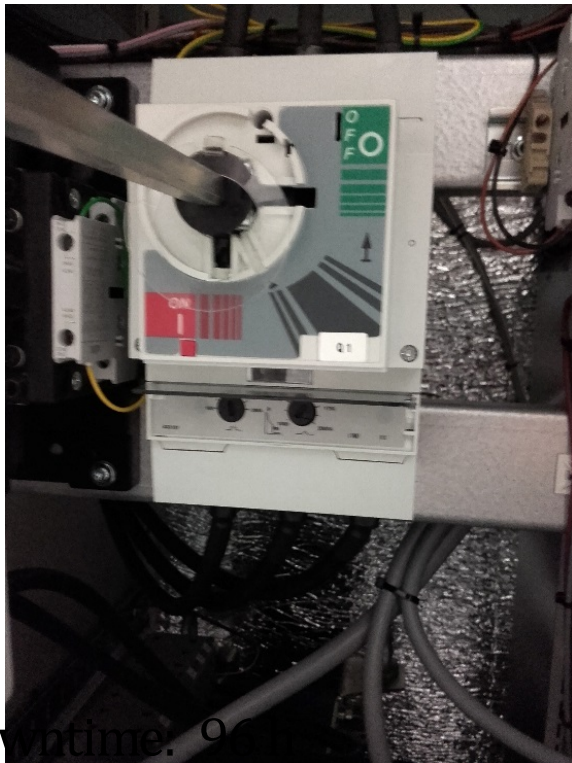
Breakdown of PS switch

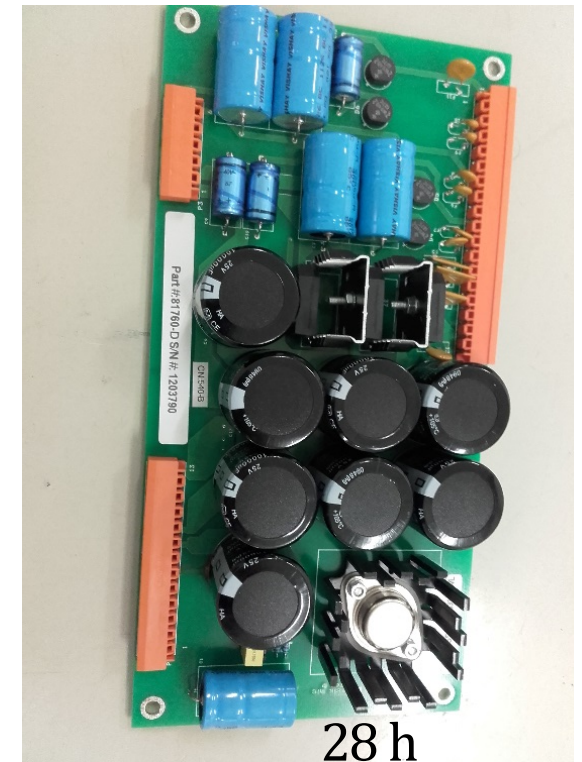
Failure of 5V inner power supply for analog part of control board

Downtime, 96 h

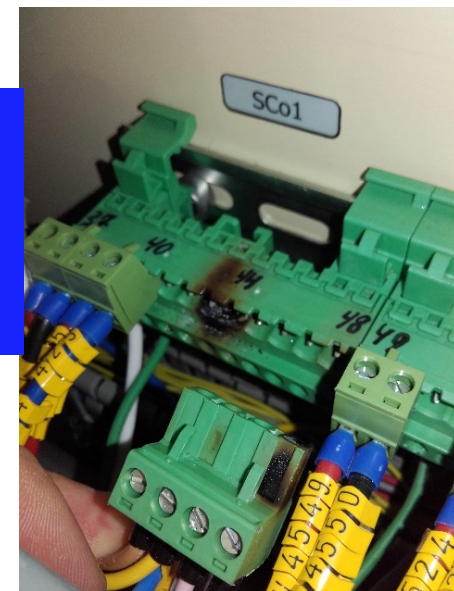
Problems with connectors for corrector magnets

Downtime: 6 h

Actions: - We are going to replace the connectors
with solid soldered cables during winter shutdown.

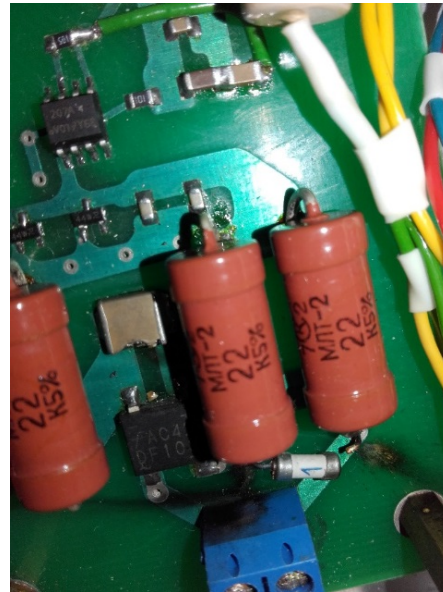
Pinger failure

- After Solaris' diagnose BINP provided us new phase detectors and replacement for other burned electronics elements;
- We are working on new improved phase detector for the Pinger;
- IGBT section (most sensitive part of the kicker and pinger) was investigated after the failure and as for now everything looks good.
