Cold Linac NPM status

Forum diags ESS at Lund November 20th 2018

CEA Saclay: P. Abbon, F. Belloni, F. Benedetti, G. Coulloux,

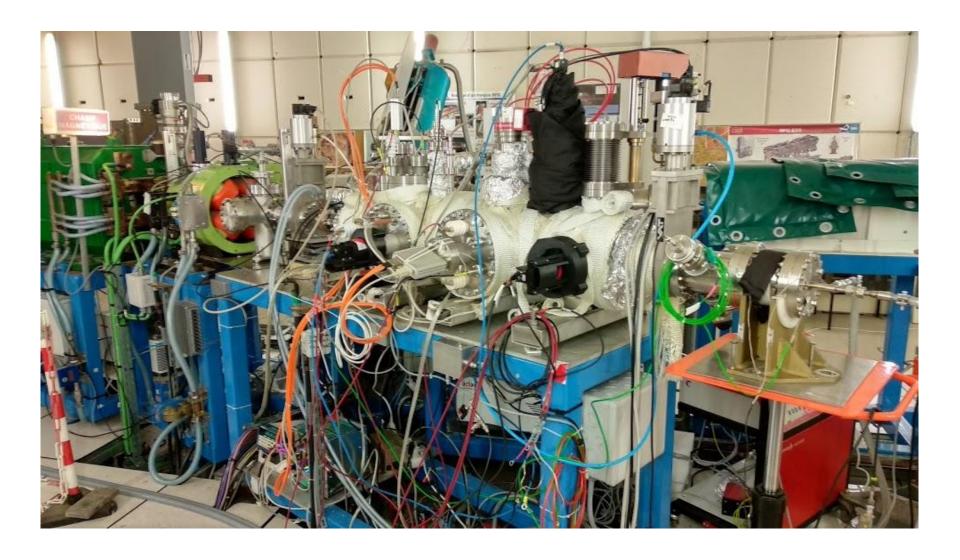
On IPHI deviated line

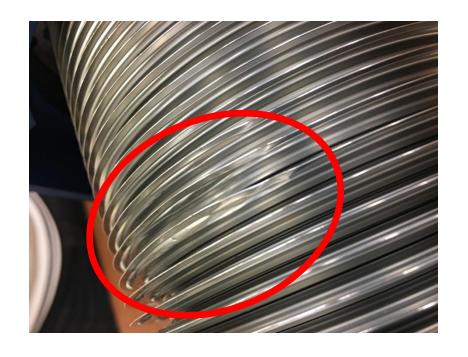
Damage 1: Transportation

Damage 1: happens during the EMU transportation between CEA Saclay (Dec. 8th 2016) and INFN Catania (Dec. 12th 2016)

The bellow of the EMU has been damaged in its wooden box

The wounded undulations of the bellow have been bended back in Catania premises.

Leak test before and after: no leak!

ESS will pay for a new bellow CEA STAFF will make the change as soon as EMU is back to Saclay.

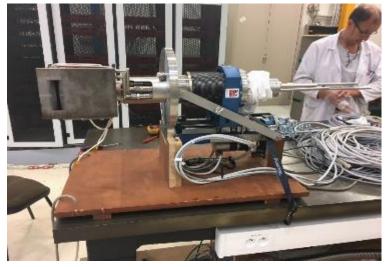
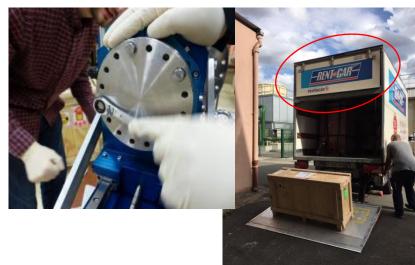
Repairing at CEA Saclay

EMU back to Saclay on November 23rd 2017

Replacing the bellow, the outer shield, the connectors with ceramics. Removing water pipes with great care for the O-ring joints, connections...

CEA Saclay exchanges the damage slits by its own subsystem
Several tests were done fulfilling the requirements as vacuum and water leaks
