A new neutron monitor for high flux neutron beams

A multitube gas-filled monitor

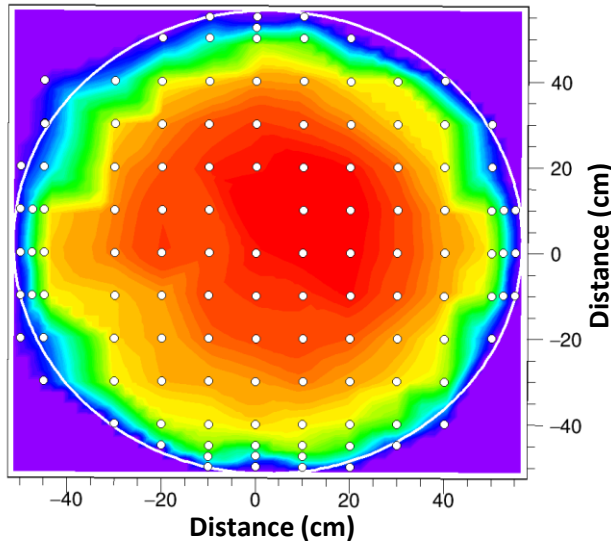
Uniformity of LND monitor n 926

Measured with a collimated (2.5 mm × 2.5 mm) 2.5 Å- neutron beam

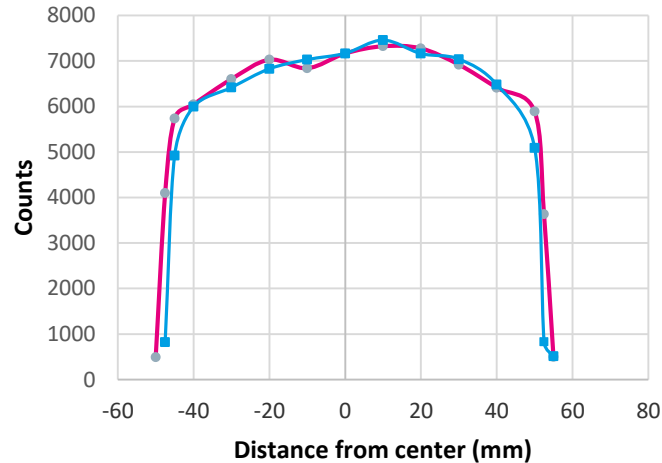
Axial Uniformity of 926 (Mod. 3053)

—●— Hor. Diameter —■— vert. Diameter

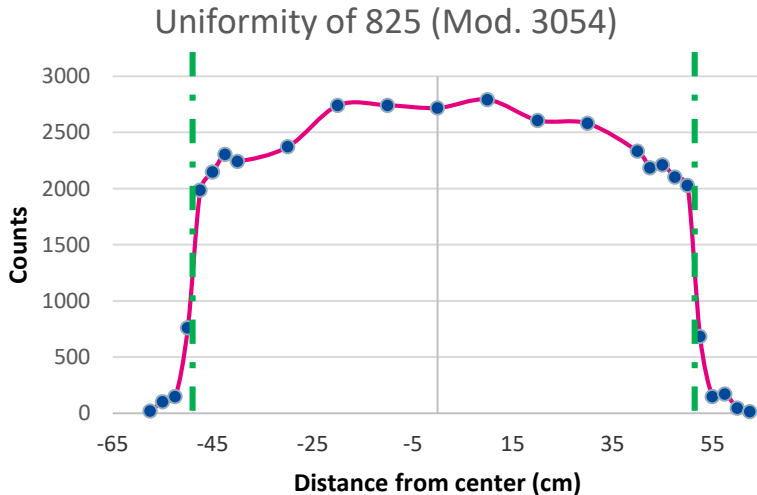
Even worse with a low efficiency one (3×10^{-4})

Uniformity : up to 20-25 % deviations

Active area : ≈ 100 mm (108 mm in specs.)

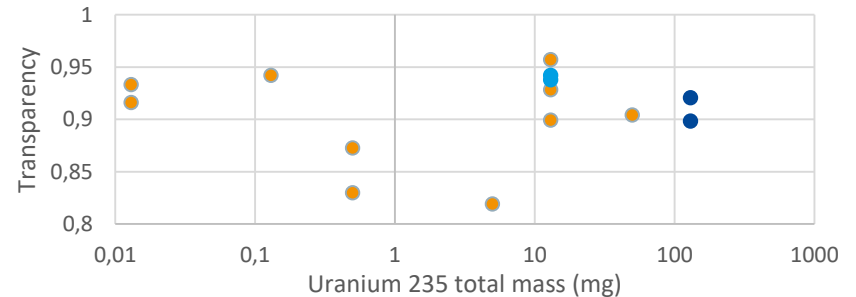
Measured transparency : 89 - 96 %

Average 91% (12 LND monitors tested)

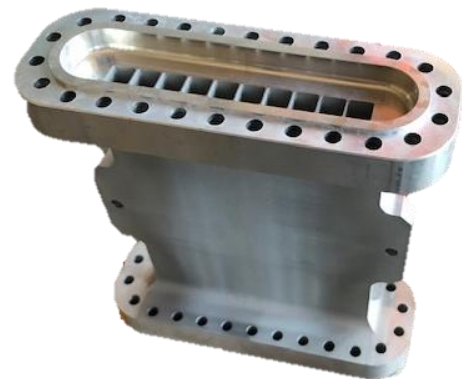
Initially designed for SHARP instrument for **operation in vacuum**

Better transparency (0.5 mm windows / 0.4 mm inner walls)

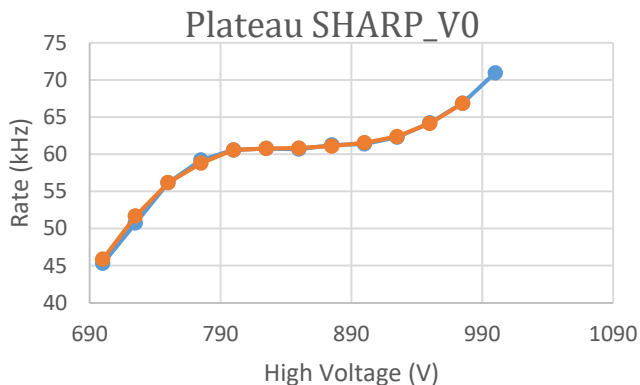
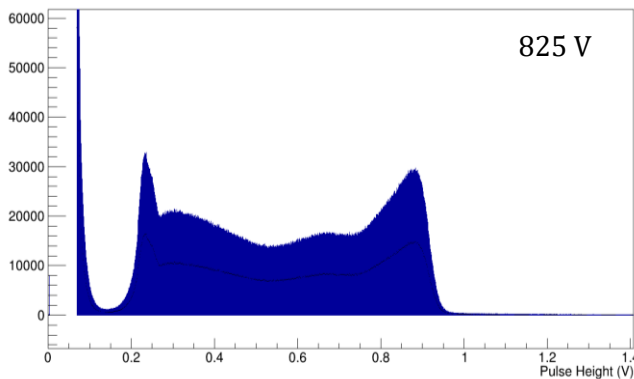
Pulse height spectra

2 bar $Ar - CO_2$
4 mbar 3He
(also tested with Nitrogen)

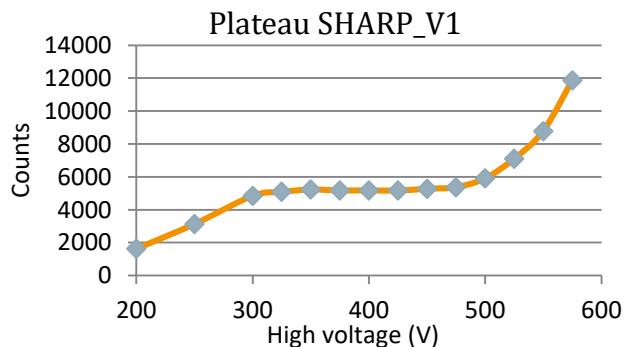
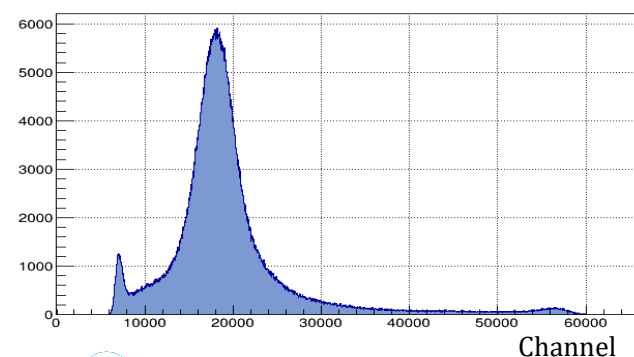
500 mbar $Ar - CO_2$
10 mbar 3He

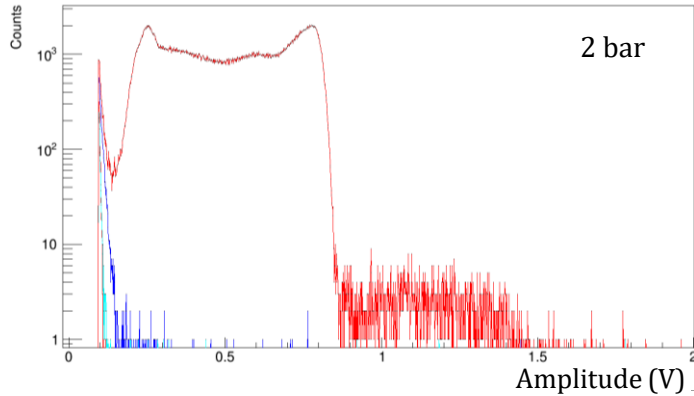
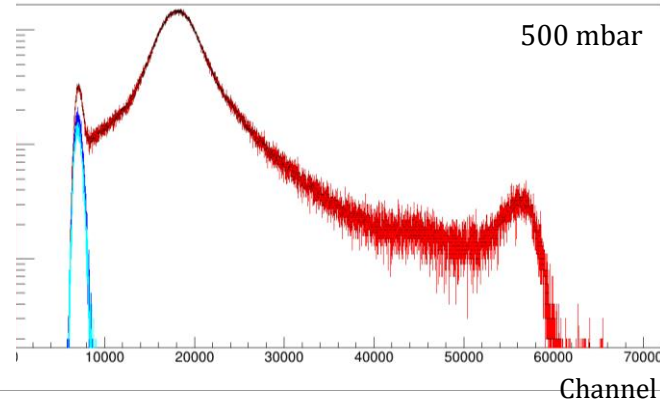
Gamma discrimination

1. Beam On
2. Beam On with B_4C shielding
3. Beam Off

Excellent gamma discrimination @ 2 bar
Even better @ 500 mbar

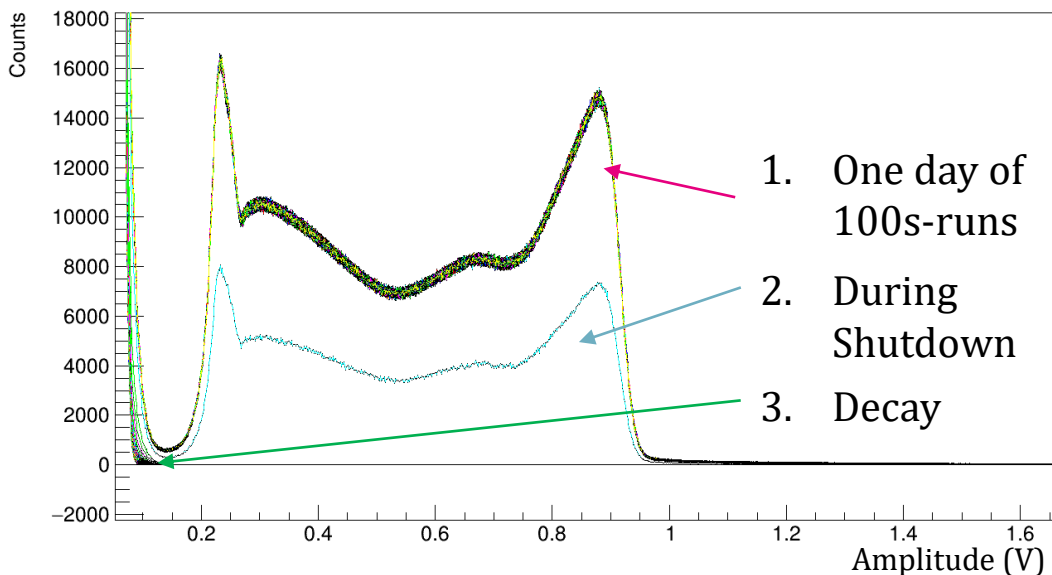
P.H. Spectra over time

60 kHz on 2 cm² over a day
On H523/SuperSUN @ ILL

inc. flux : $\sim 2 \times 10^7 \text{ n.cm}^{-2}.\text{s}^{-1}$

Good stability – No charging effect
No shift on PH spectra

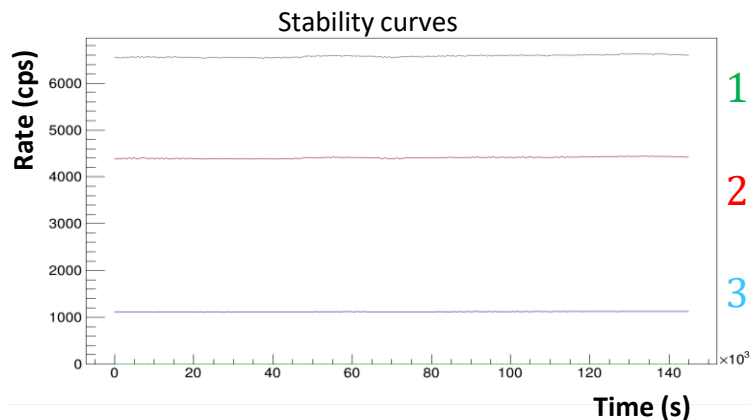
Two day of measurements with 3 monitors

1. U - monitor 1

2. Sharp_V1

3. U - monitor 2

$\approx 0.2\%$ counting rate variations
(stat. err. $1.6 \times 10^{-1}\%$)

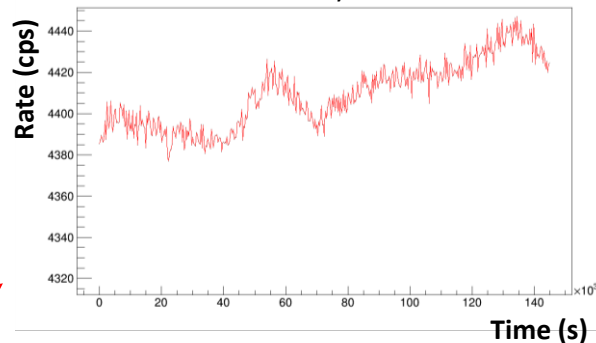
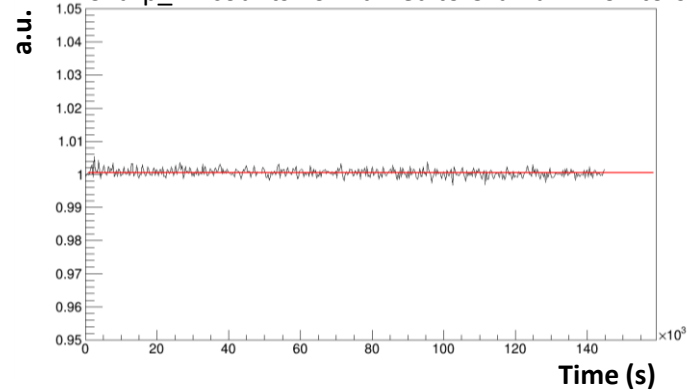
Beam intensity variations

Sharp_V1 counts normalized to Uranium monitors

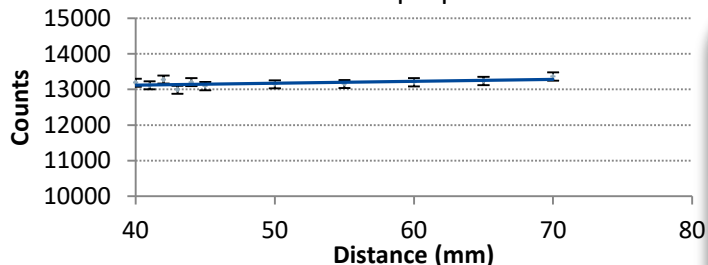
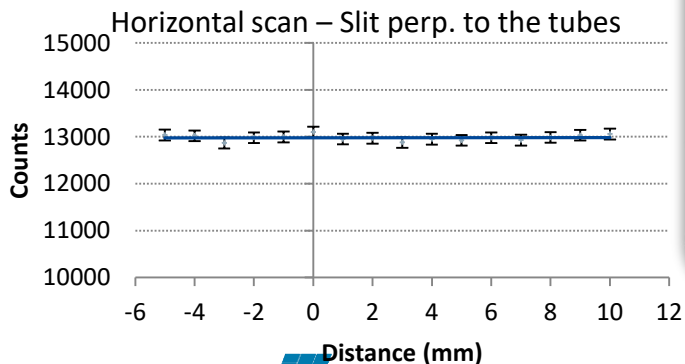
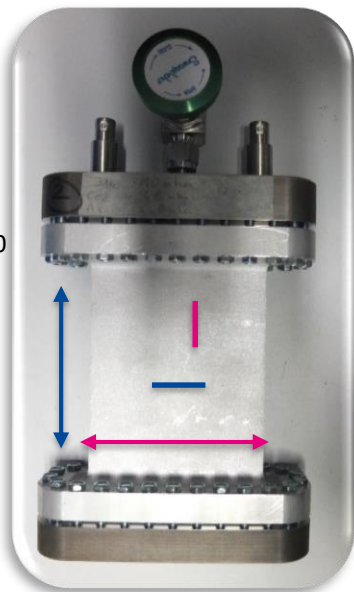
Beam collimated with a slit (0.5 mm x 12 mm)

Vertical scan – slit perp. to the tubes

In the normal case of use with slit apertures, uniformity is great (std. dev. < 0.5 % hor. / < 0.8 % vert.)

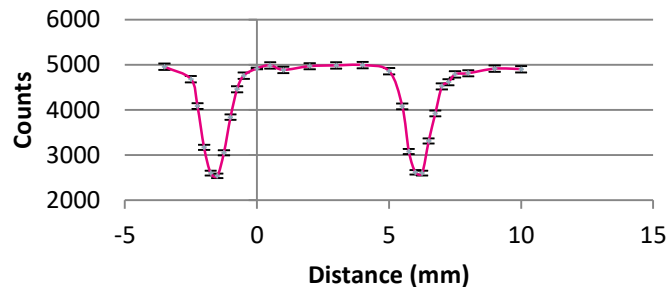
Horizontal scan – slit parallel to the tubes

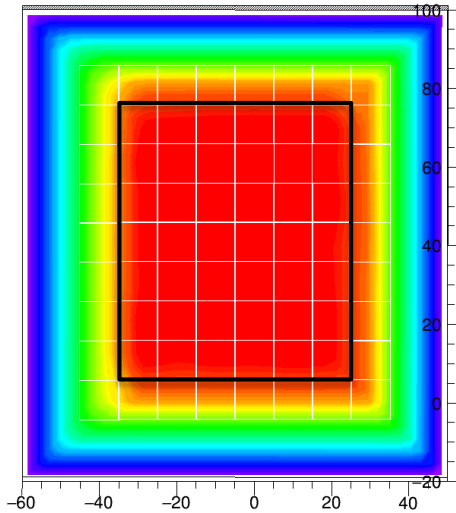
Beam collimated with a mask (20 mm x 20 mm)

-Efficiency mapping within the active area shows a very uniform detector all over the surface

- Statistical uncertainty : 0.4 %
- Std deviation : **0.6 %**

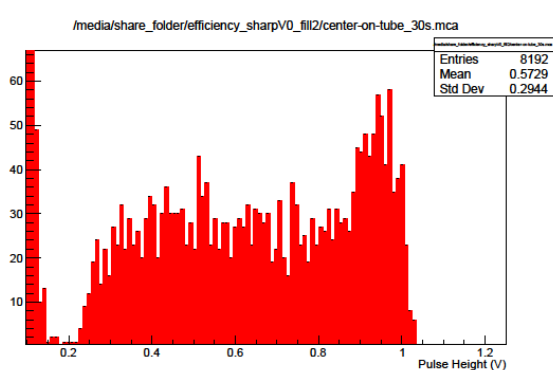
2.5 mm slit
centered on tube

Structure observed in the spectrum seems to be due to the presence of Al walls

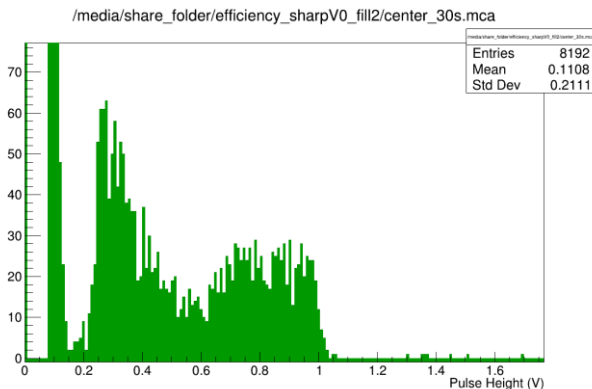
2.5 mm slit centered on
detector (Al wall)

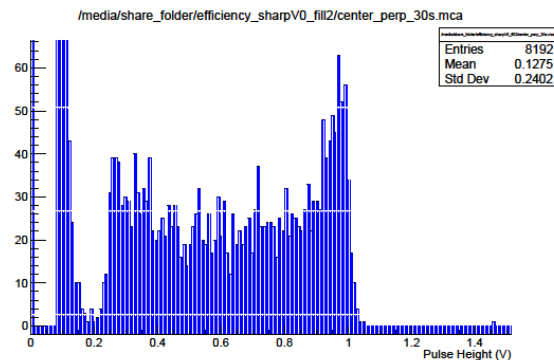
2.5 mm slit perpendicular
to the tubes
