Experience of Klystron Operation at J-PARC LINAC

J-PARC Center, JAEA
Yasuhiko Fuwa

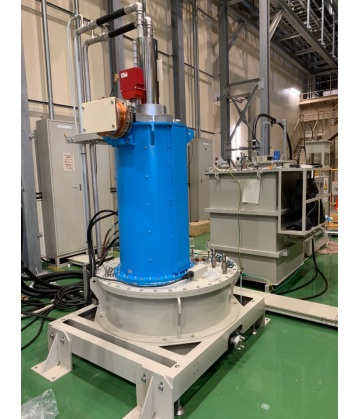
CETD E3740A

Specification of klystrons

Frequency:	324/972 MHz
Peak Power:	3 MW (Averaged Power: 93 kW)
Gun type:	Anode-Modulating type
Pulse Length:	620 micro-sec.
Repetition Rate:	50 pulses per second (operated with 25 pps in J-PARC LINAC)
Beam Voltage:	110 kV
Beam Current:	50 A
Efficiency:	55%

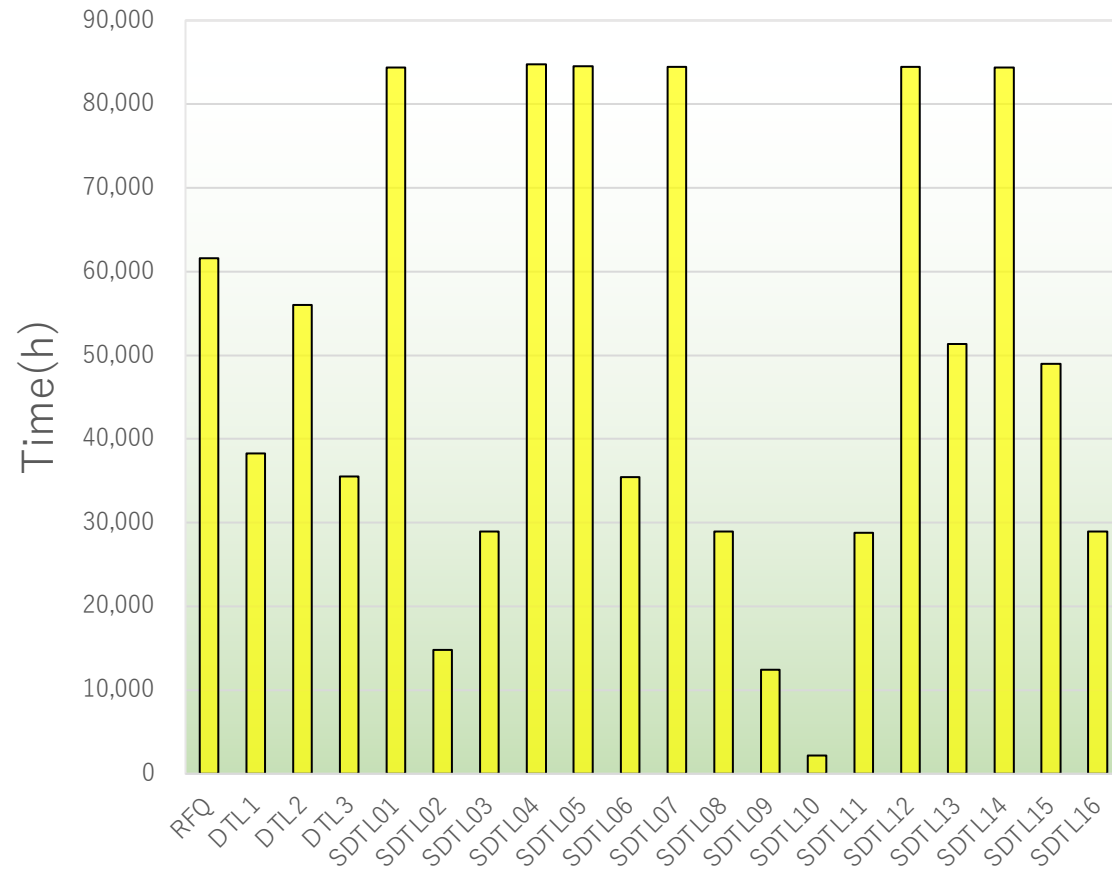
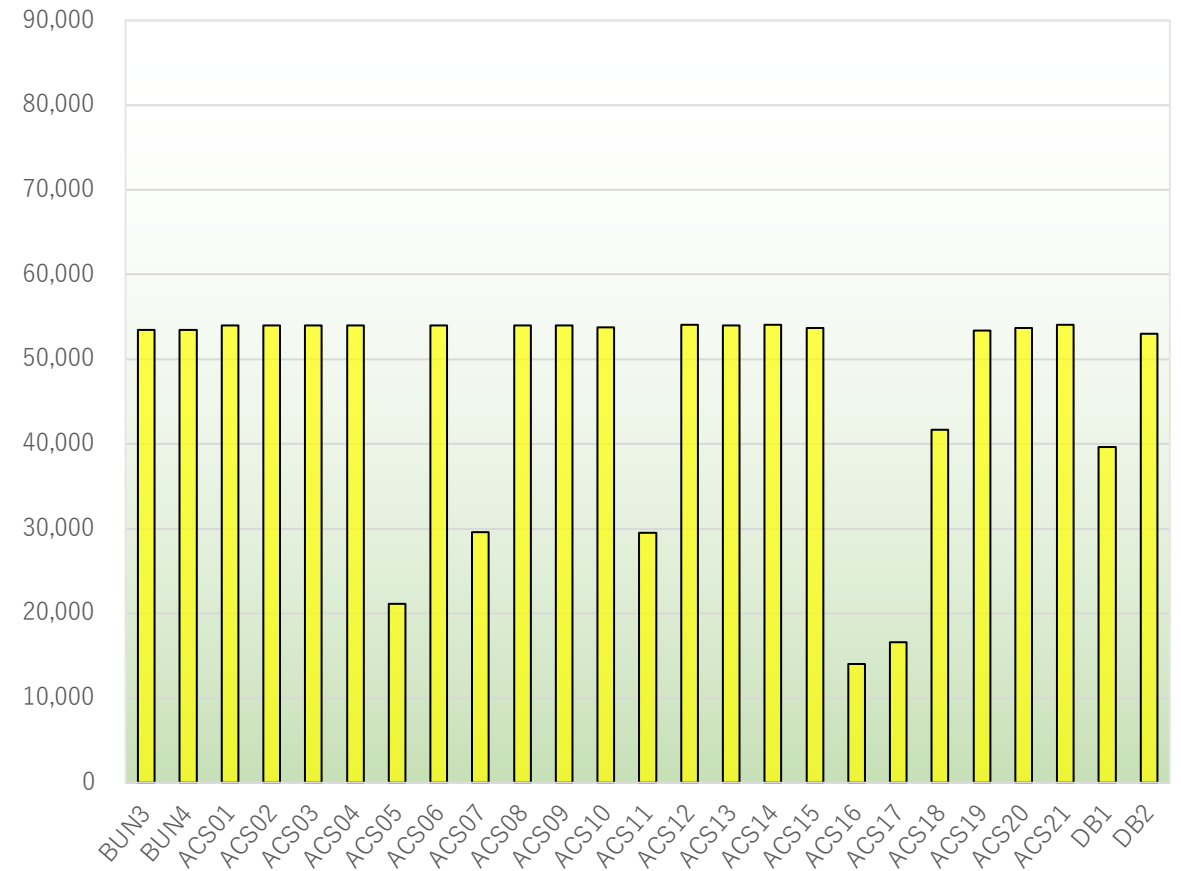
Operation Time of Klystrons (July 2022)

The 324-MHz klystron, which has been in use since 2006, has reached 84,000 hours of operation. The 972-MHz klystron, which has been used since 2014, has reached 54,000 hours of operation.

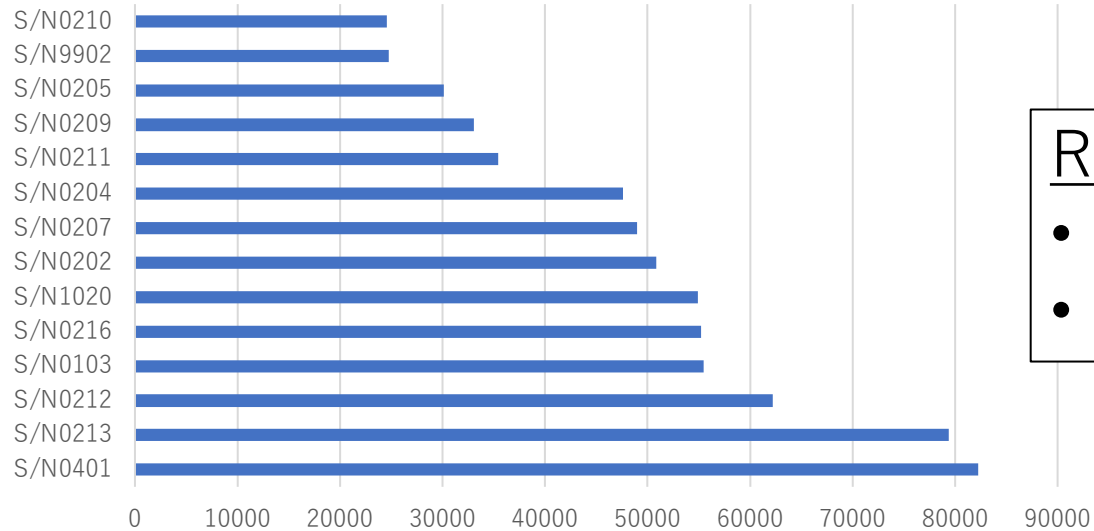
324-MHz klystrons: 14 tubes were retired during 16 year operation

Reason for Termination of use [324-MHz KLY]

- Discharge at electron gun (13 tubes)
- Degradation of vacuum in tube (1 tube)

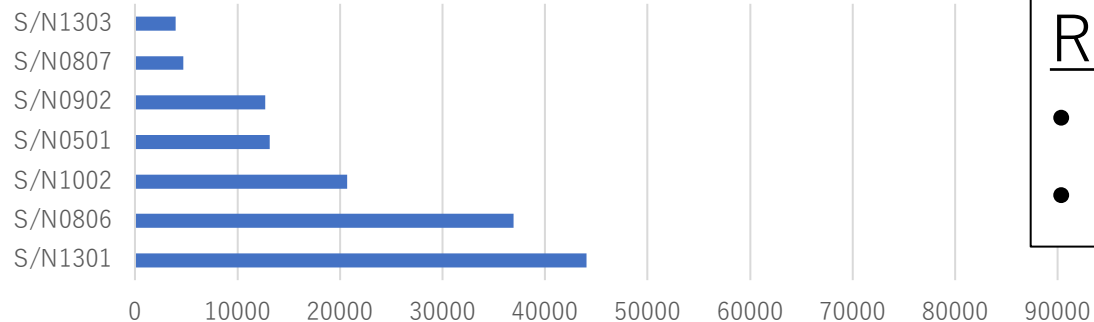
972-MHz klystrons: 7 tubes were retired during 8 year operation

Reason for Termination of use [972-MHz KLY]

- Discharge at electron gun (5 tubes)
- Water leak (2 tube)

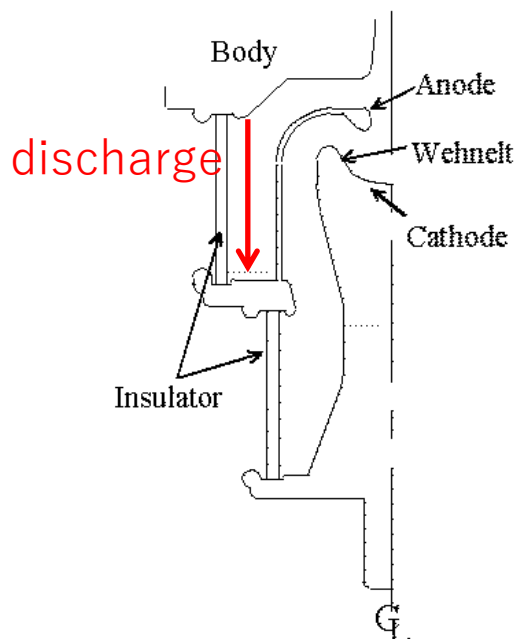
The klystrons for J-PARC have electron gun with a triode configuration, so the distance between the gun electrode is short. Therefore, the electric field on the electrode surface is relatively large, and discharges are likely to occur.

Cross section of electron gun

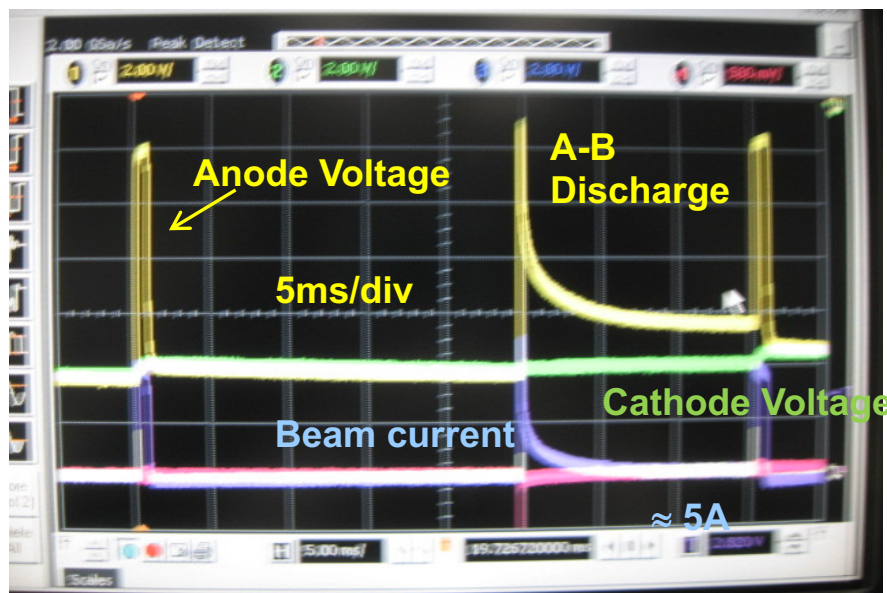
↑ discharge event in 324-MHz KLY

To reduce the risk of discharge, the voltage of the klystron high-voltage power supply is set to the minimum required voltage, which is lower than the rated value of 110 kV.

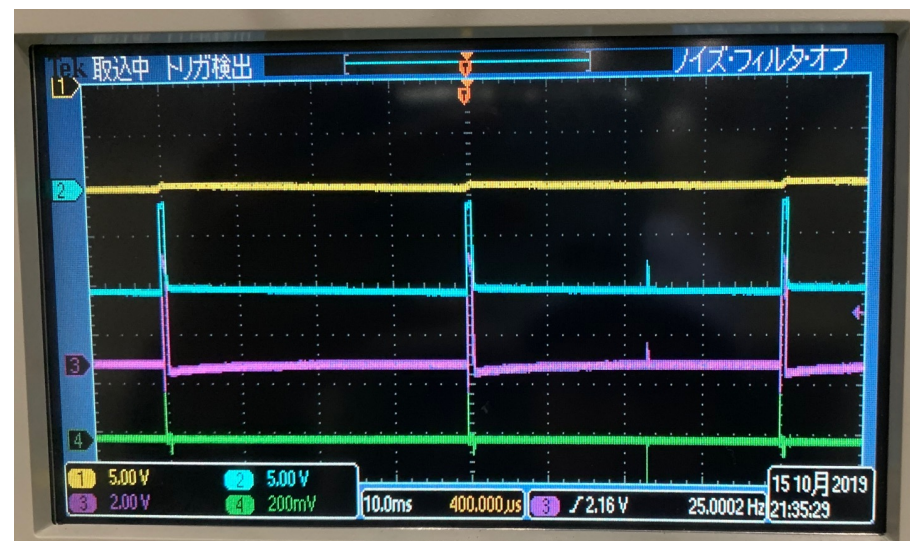
↑ discharge event in 972-MHz KLY

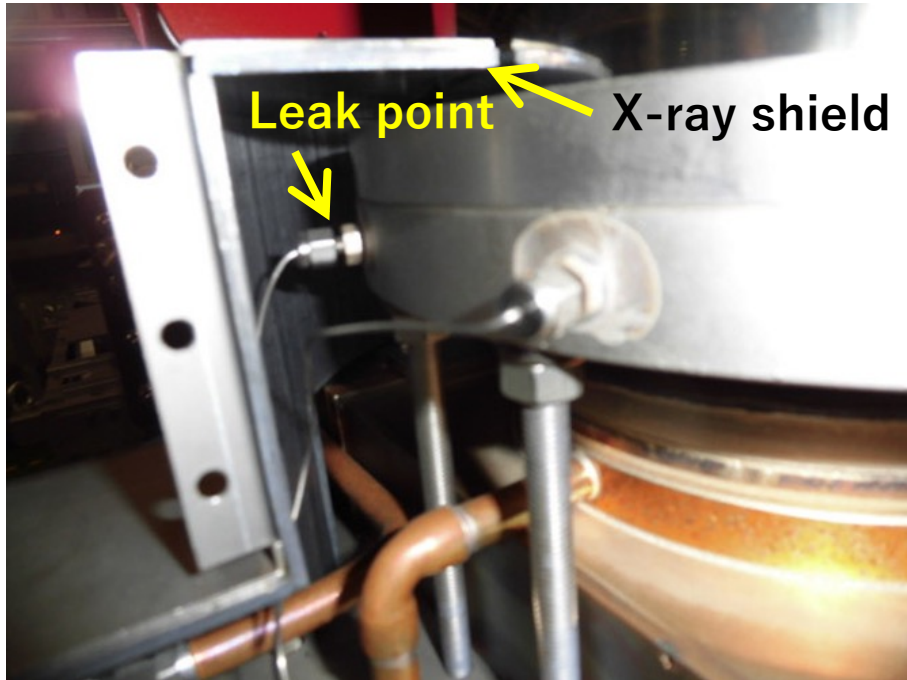
Leak point: brazed part between the flange and the thermocouple socket.

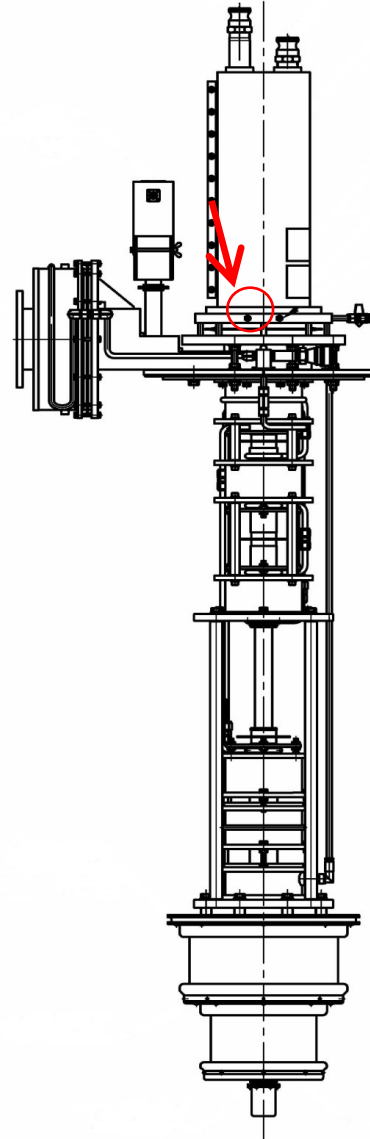
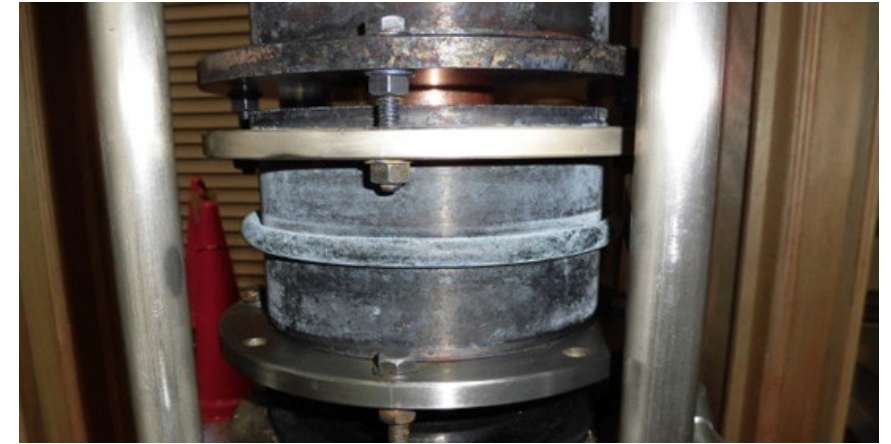
Exposed to high humidity for a long time.

The X-ray shield hit the thermocouple socket, when installing the shield in J-PARC.

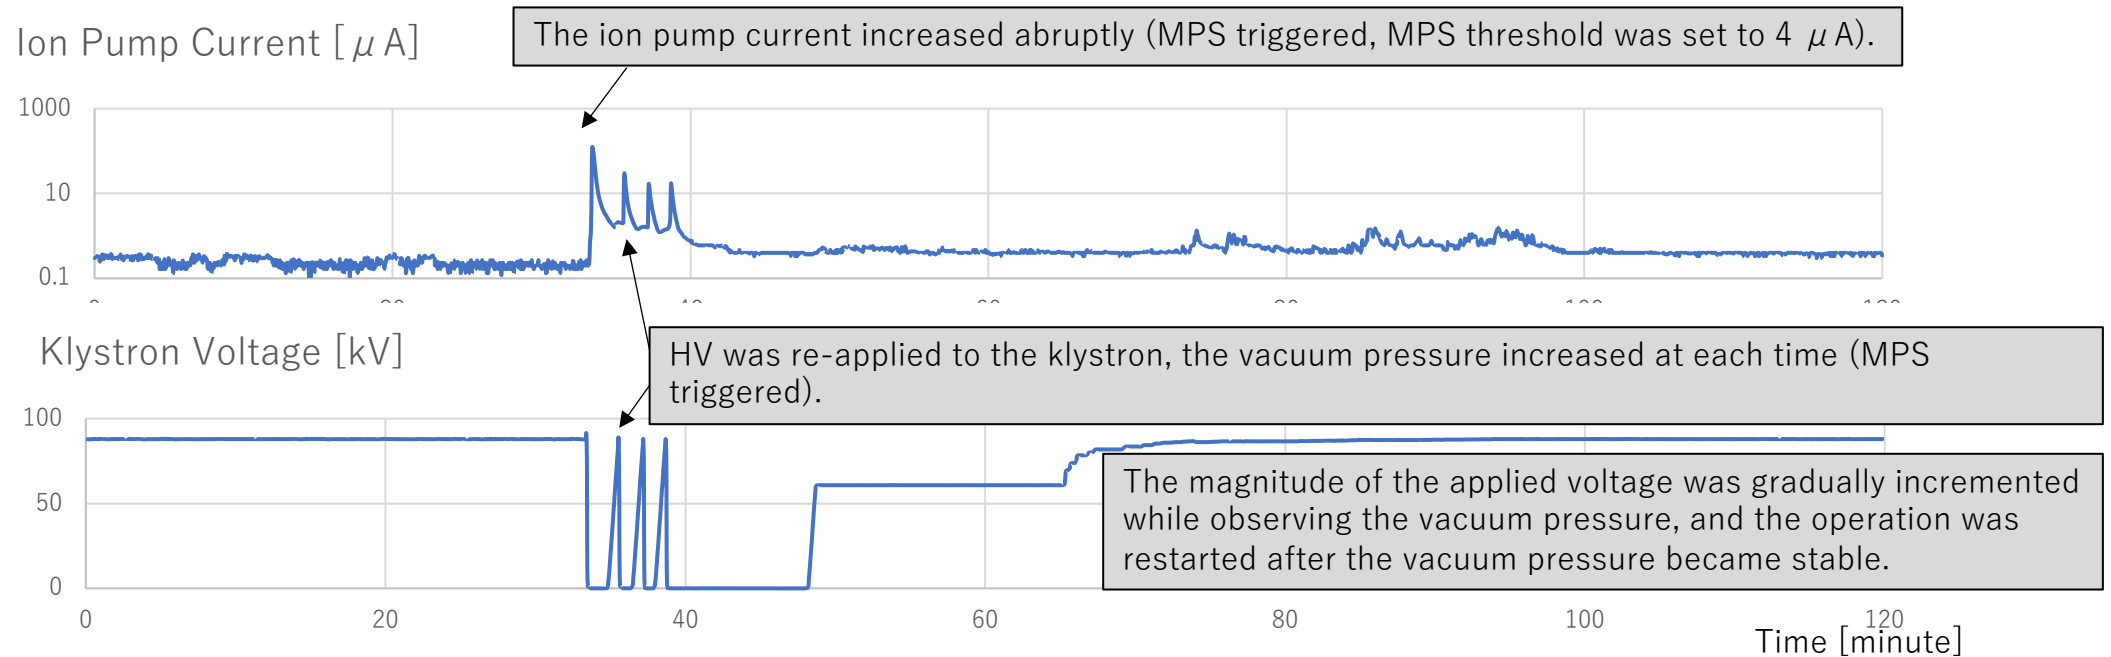
- One 324-MHz klystron was replaced due to deterioration of vacuum pressure. (A typical vacuum failure event show below.)

- **Similar events have been occurring with lower frequency for several years, however, the number of such events has increased in the last operation period (11 events occurred from Nov. 2020 to Jul. 2021).**

- The operating time of the klystron tube is over 80,000 hours, which is much beyond the tube life presumed by the manufacturer (50,000 hours).
- We assessed that this vacuum deterioration was due to the end of klystron's life and decided to replace it.

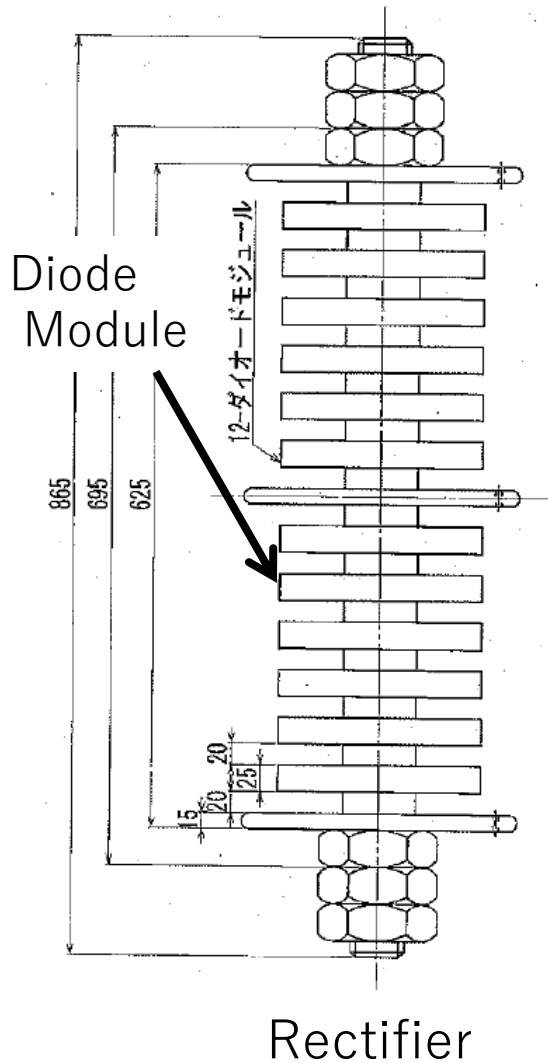
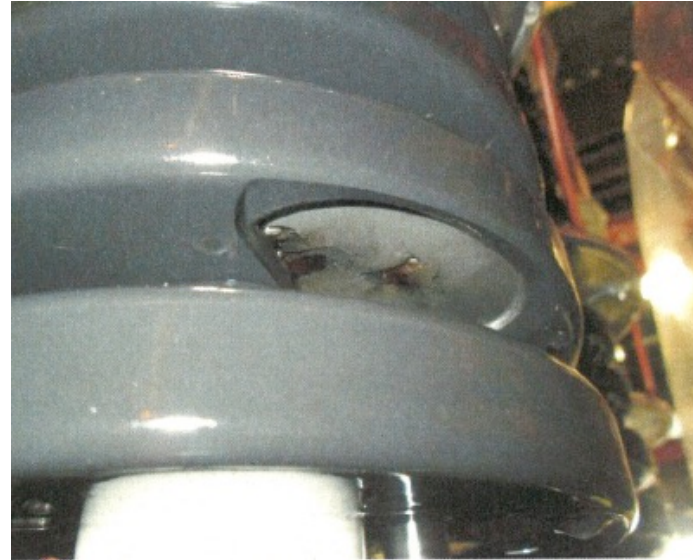
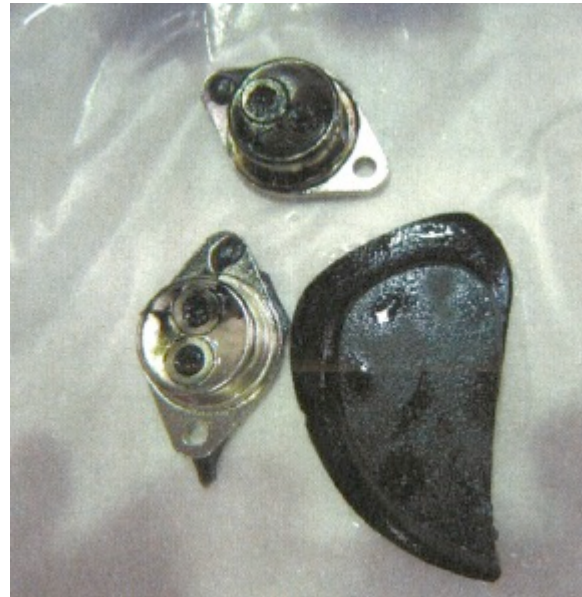
Breakdown of HV Rectifiers

Diode Modules in the klystron HVDC power supply were broken due to over voltage.

Parallel capacitors in diode elements has temperature dependence and elements near the input terminals were heated.

-> An imbalance in voltage dividing and breakdown occurred.

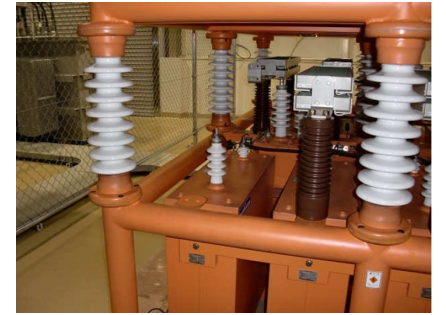
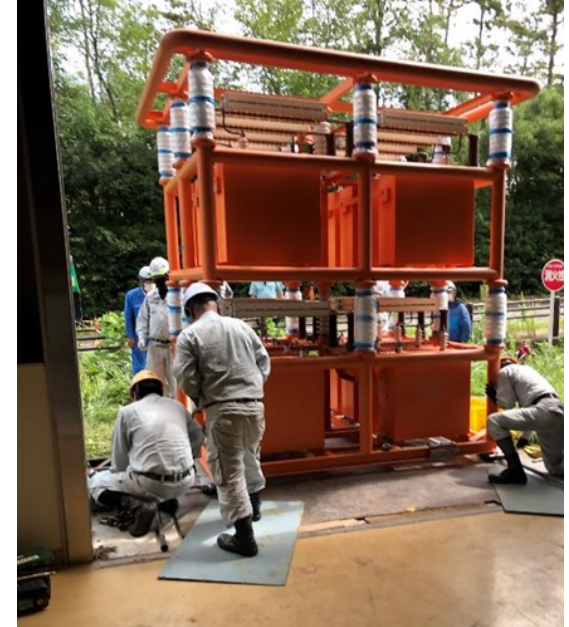
Oil Leakage from Capacitor

Oil leak from one of the capacitor package in Capacitor Bank(C-Bank) have found on high voltage power supply system #3 in summer maintenance of 2019.

There was a slight defect in the welded area, which led to oil leakage after a long operating time.

Although no other damaged capacitors have found, many C-Bank have been **operated for over 15 years**.

To ensure safety, replacement of the C-Bank with new model has been going on since 2020.

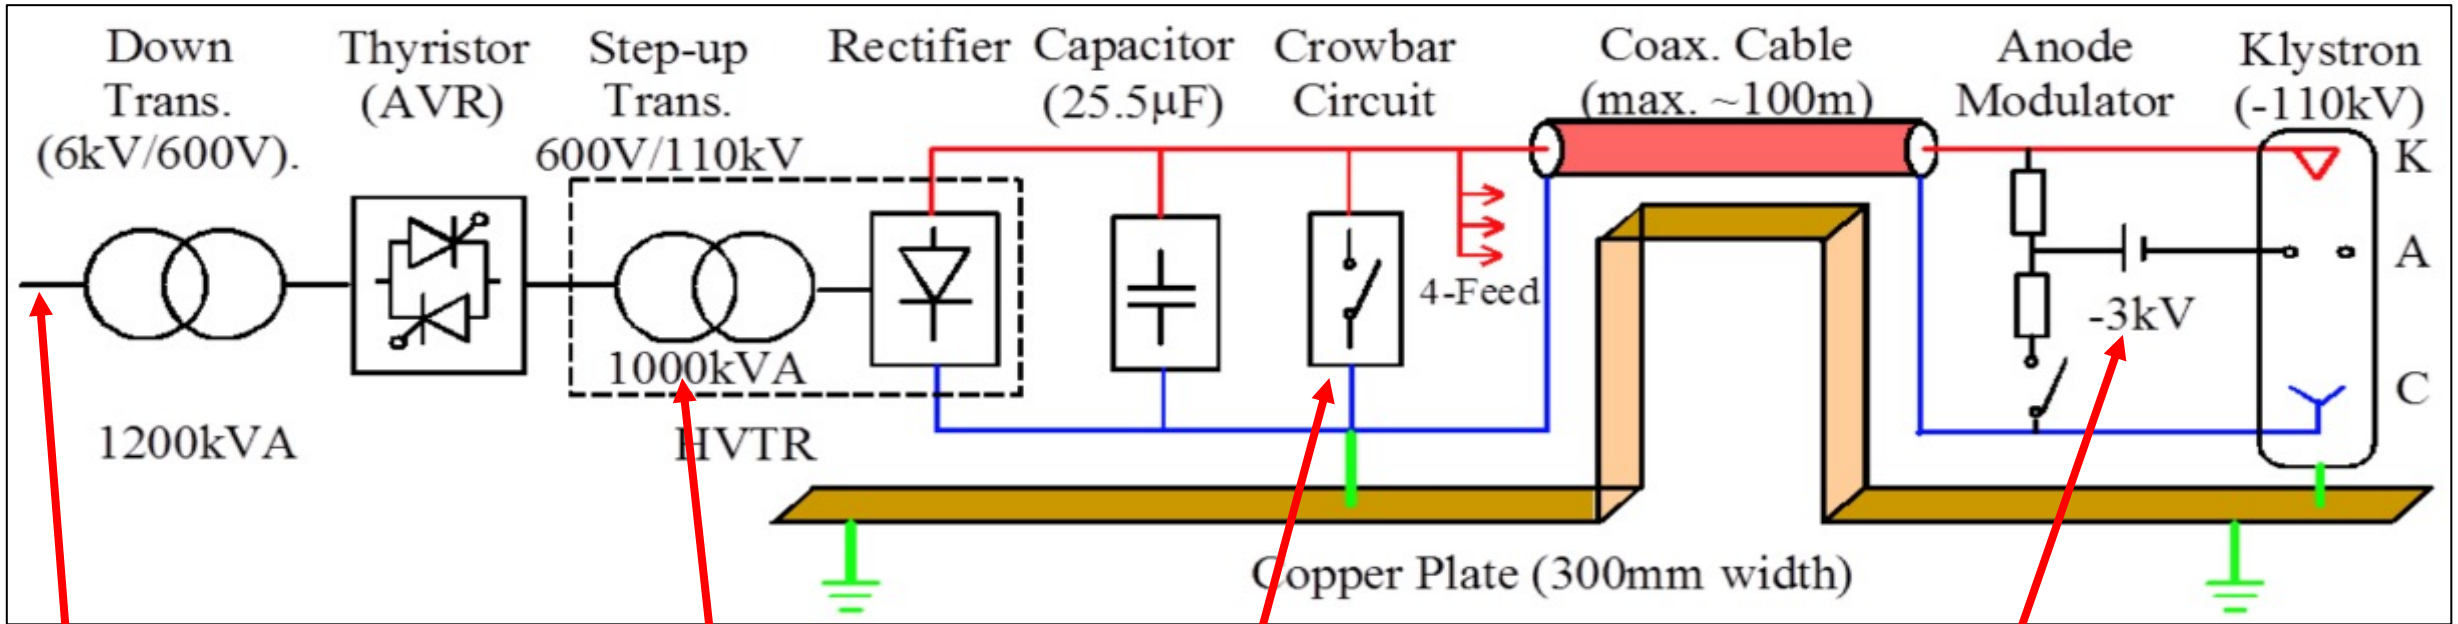
Components with Age-Related Deterioration

6600-V Vacuum Circuit Breaker

Step-up Transformer

Ignitrons in Crowbar

Bias Power Supply for Modulating Anode

More than 15 years have passed since the start of operation, and many components have begun to show age-related deterioration. A long-term plan for replacement is needed to assess the trend of component deterioration.
