The New High-Angle Detector for the Bio-SANS Instrument at HFIR

Kevin Berry

DENIM

September 19, 2016

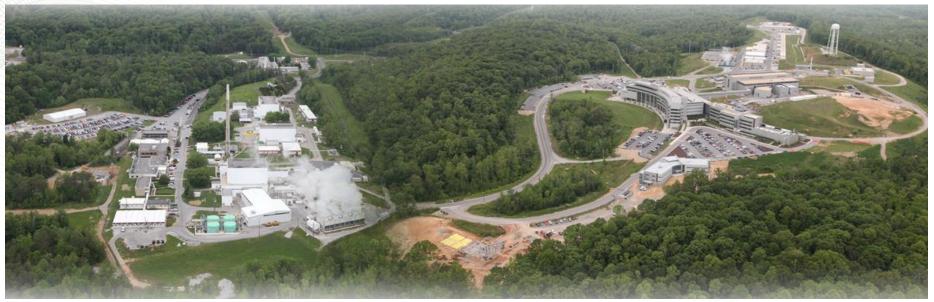
Two neutron sources at ORNL

- High Flux Isotope Reactor (1965)
- 85 MW, peak thermal flux >2x10¹⁵/cm²-s
- Thermal and cold neutron beam lines
- Cold neutron source, guide hall commissioned in 2007
- 7 cycles/year (~ 24 days per cycle)
- 12 instruments in user program, 2 development beam lines

- Spallation Neutron Source (2006)
- > 1 MW continuous operating power
- 60 Hz rep rate, peak flux >1x10¹⁴/cm²-s
- Plans for power upgrade to 2.8 MW
- 17 instruments in user program
- Plans for 2nd target station with up to 22 new instruments

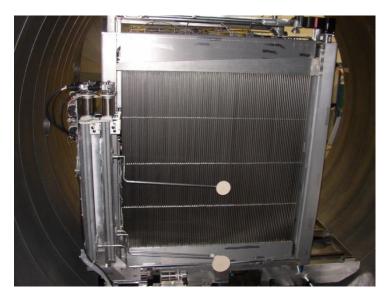
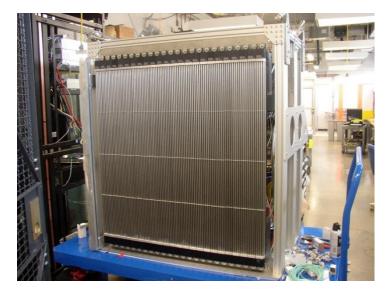
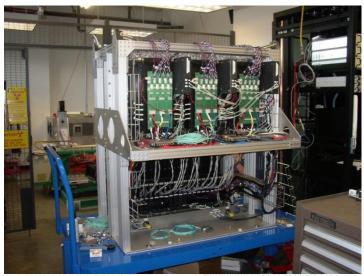
Detector replaced with LPSDs in 2012

- helium-3 filled linear position sensitive detectors (LPSD)
- 192 tubes assembled into 24 '8-packs' (GE Reuter-Stokes)
- 1 m x 1 m active area
- two row design, front and back rows offset, each row contains 96 tubes
- tubes 0.8 cm diameter x 1 meter length
- identical to GP-SANS detector (2011) very similar to EQ-SANS at SNS (2008)

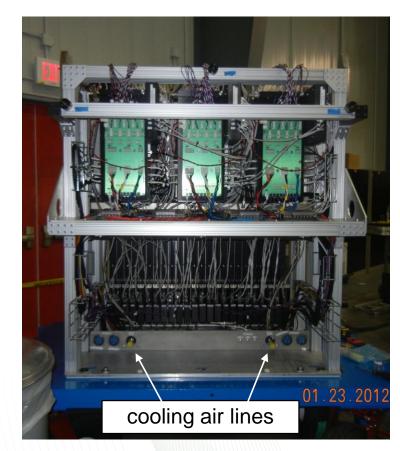
Additional requirements – improved vacuum, cooling, and interlocks and controls

- Vacuum upgrade < 2 mTorr to prevent arcing
 - HV components now in vacuum space
- Cooling air lines to control electronic circuit board temperatures to < 50 °C
 - circuit boards in vacuum, densely packed
- Interlock system to control interplay between high voltage, detector motion, air flow
 - high voltage dropped if vacuum goes bad (arcing, damage to electronics)
 - high voltage dropped while motion enabled (anode wires short out, damage to tubes)
 - low voltage dropped if cooling air flow too low (overheating, damage to electronics)

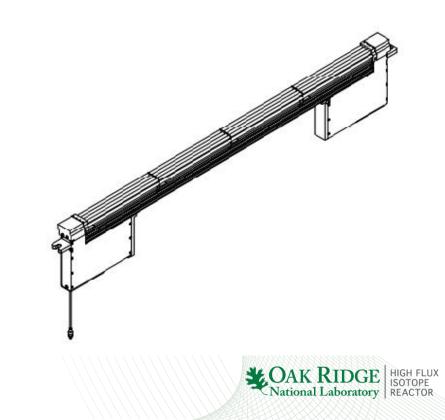
Early diagram of proposed new detector locations

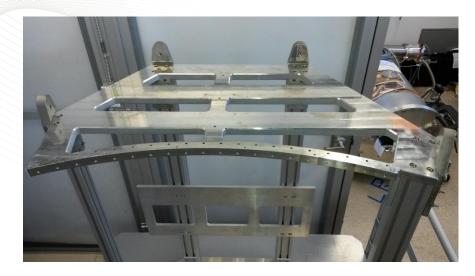
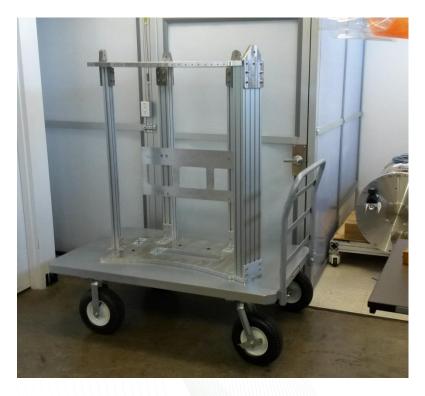
Curved mounting frame built to hold the 20 new detector modules

Mounting frame delivered to detector lab at SNS

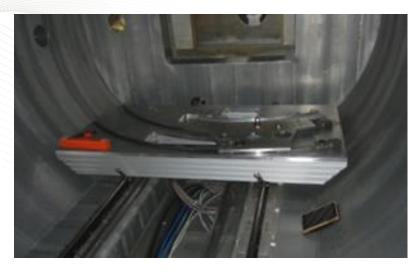
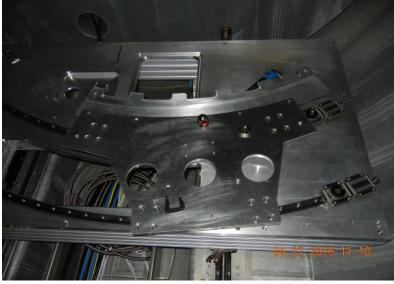
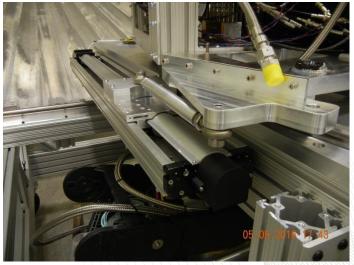
Radial motion - curved rails, linear translation stage, pivoting drive arm

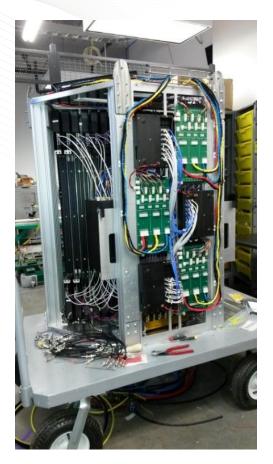
Rear view

Detectors, electronics, and cabling all coming together in the detector lab

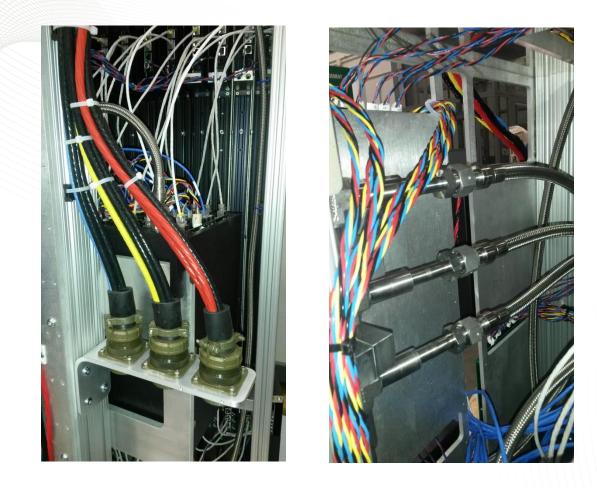
Connections for power, cooling air

Low voltage connectors, cooling air manifold, and VCR fittings for attaching air lines

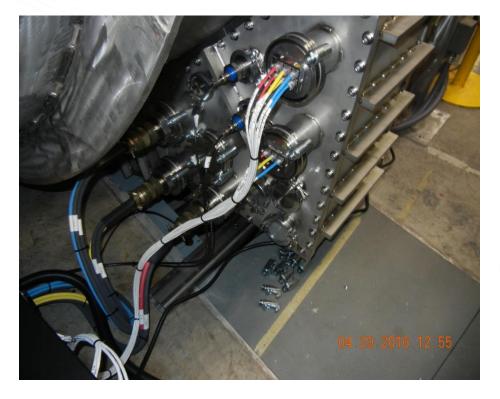
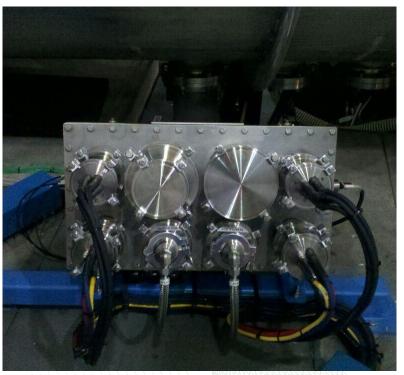
Feedthrough expansion chamber was installed during a previous outage to maximize resource availability during installation outage

Needed more feedthrough area than existing flanges could provide

Similar to what was installed for main array in 2012

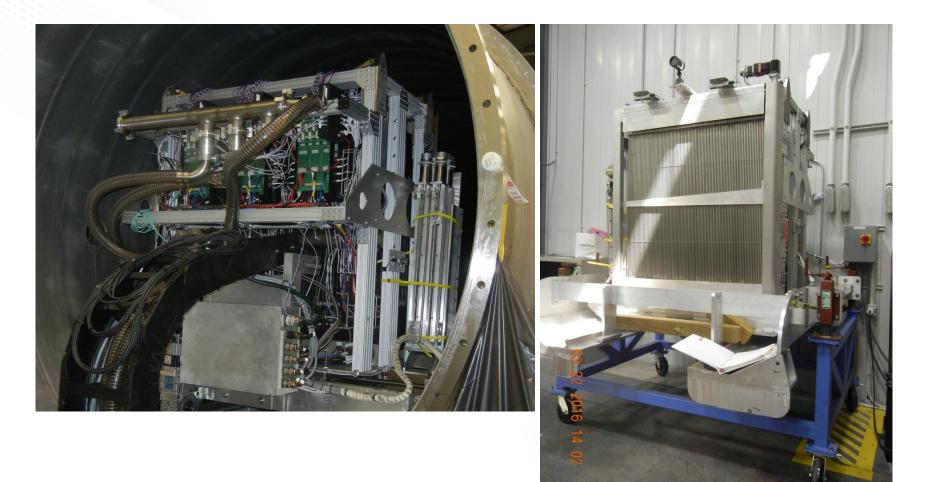
Prior to installing the new detector, first needed to disassemble and remove the main detector from the tank

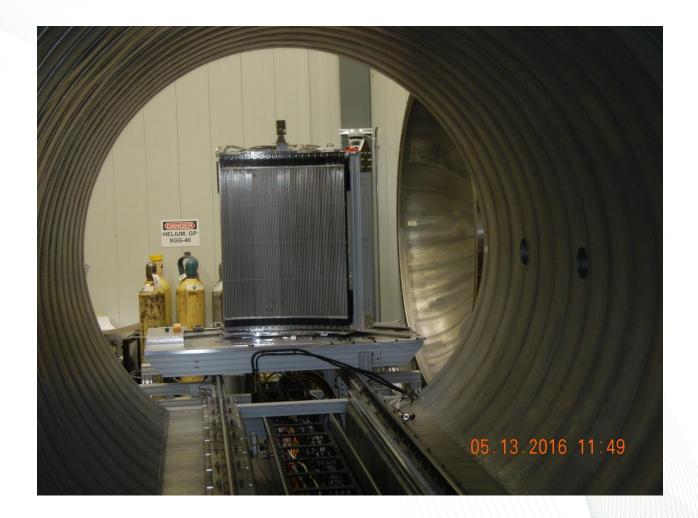
Test fit before detector moved into position at front of tank
