DENIM 2016

Maria @ FRM2 an EMI survey

Sep 2016 | G. Vehres

MARIA: Magnetic reflectometer with high incident angle

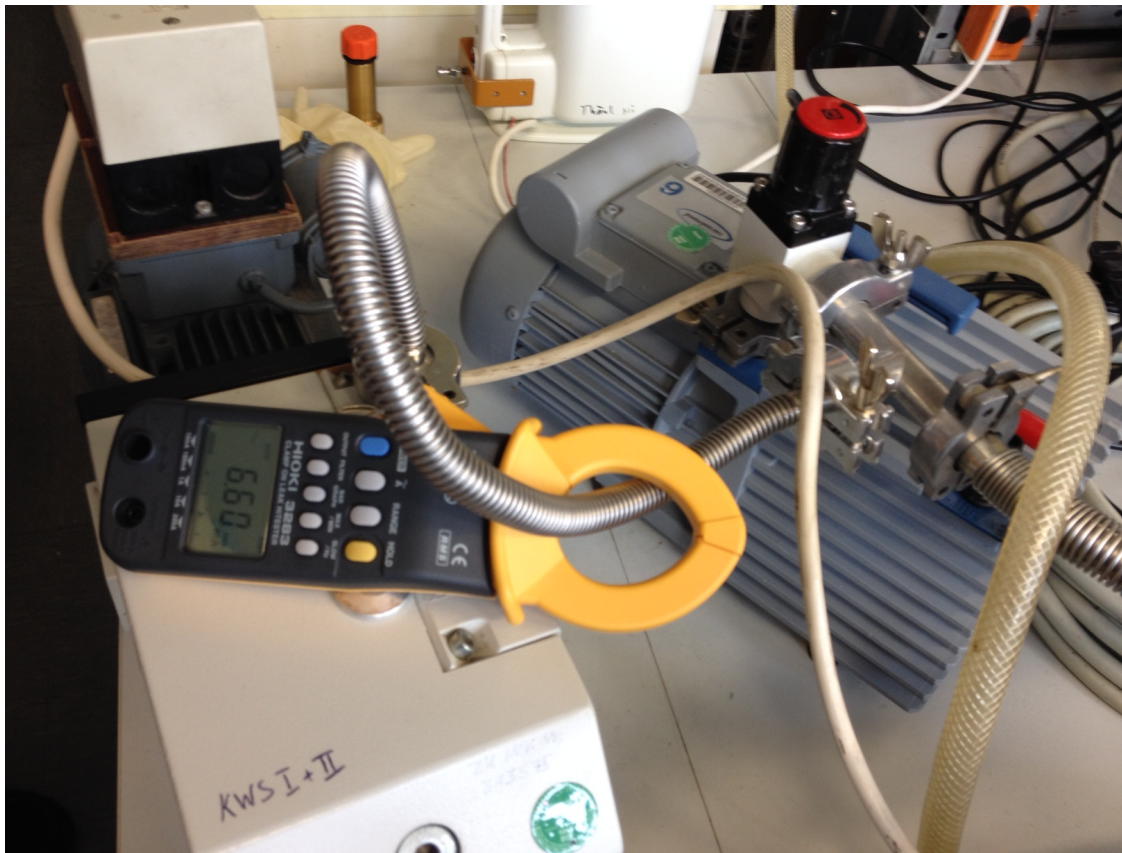
Current through vacuum hose ~ 6mA (30kHz)

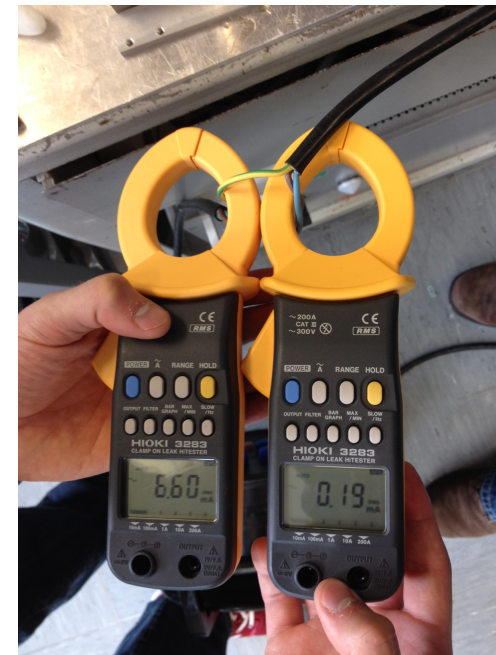
Two pumps
Each supply from
different feed.
One within this lab,
one from a
neighborhood lab
25m extension cord

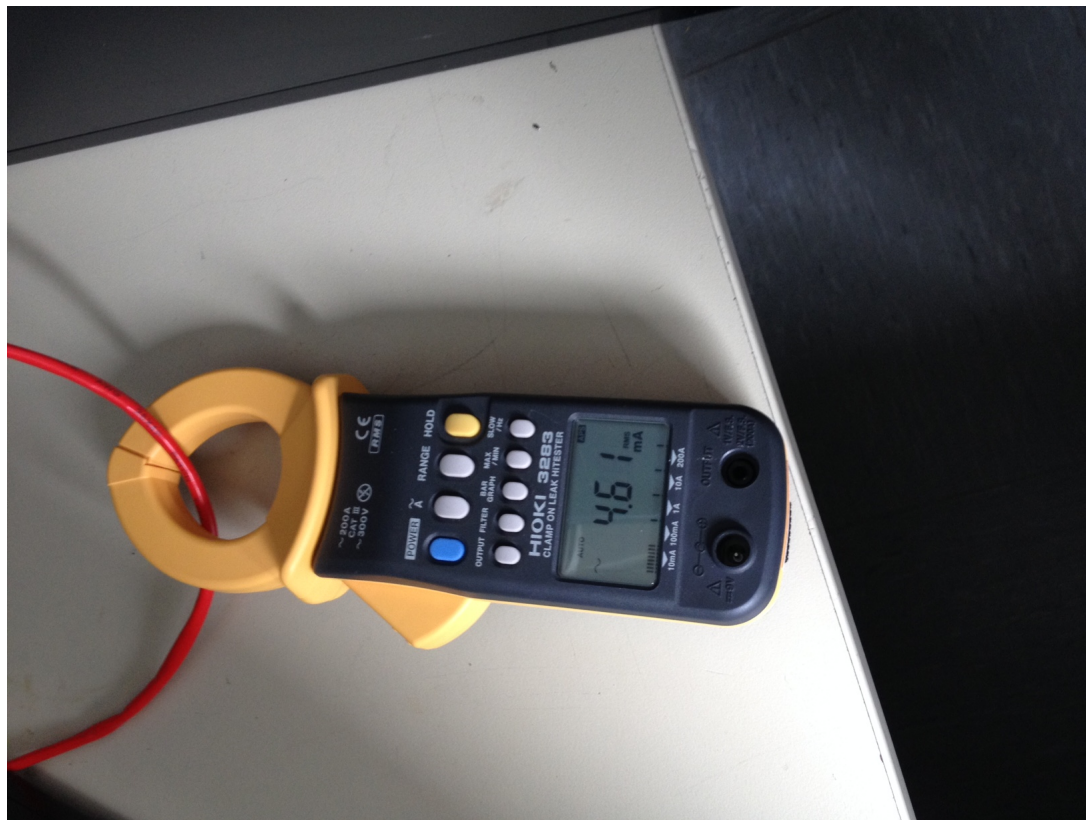
Current through network cable ~ 5mA

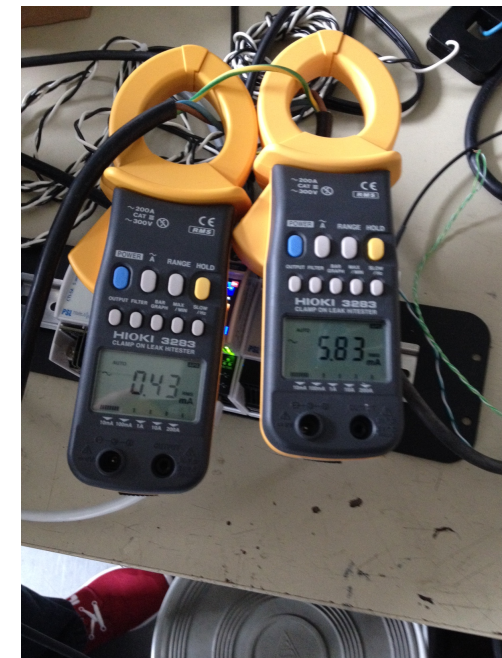
System connected to a switch next floor using 30m shielded Network cable.

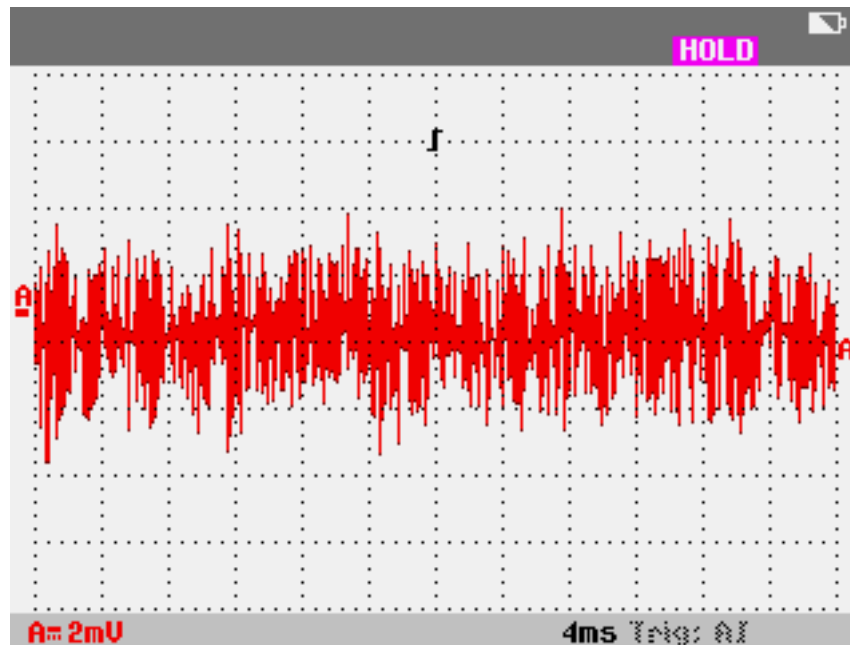
Detector system

10mA/Unit

Leak current main frequency 250kHz on the supply line of the „Siemens“ rack.
The measured current depends on the position of the ribbon cables

Guess: a ribbon cable is damaged and strikes the rack / ground
Insulation fault! The detector is no more isolated!

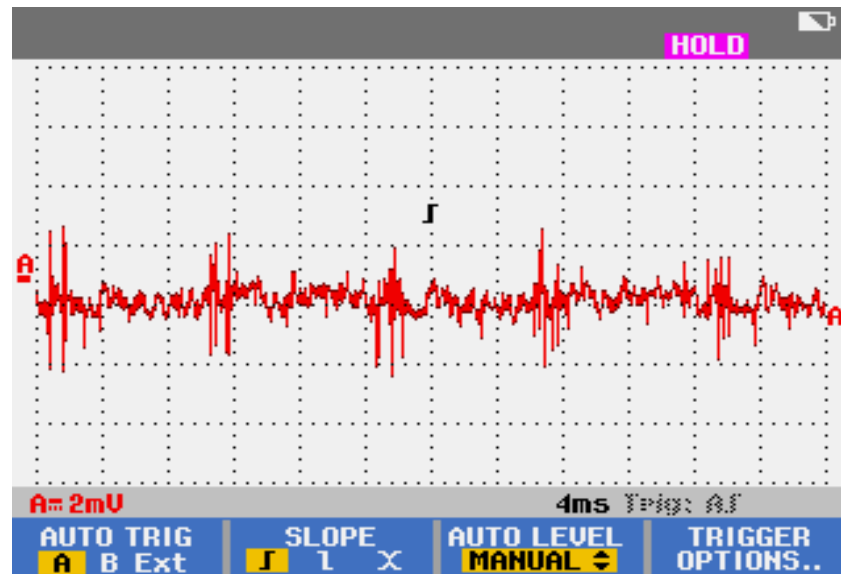
Friction wheel / Hexapod

Discontinuous interference measured at the motor cable of the friction wheel

10mA/Unit(20mA) 4ms/Unit

Guess: A Loop is created!!

The motor cable supplying the friction wheel is screened but also includes a ground wire. Both are connected to the equalisation point of the hexapod control unit (at the primary spectrometer).

The motor itself is mounted on the secondary spectrometer without insulation.

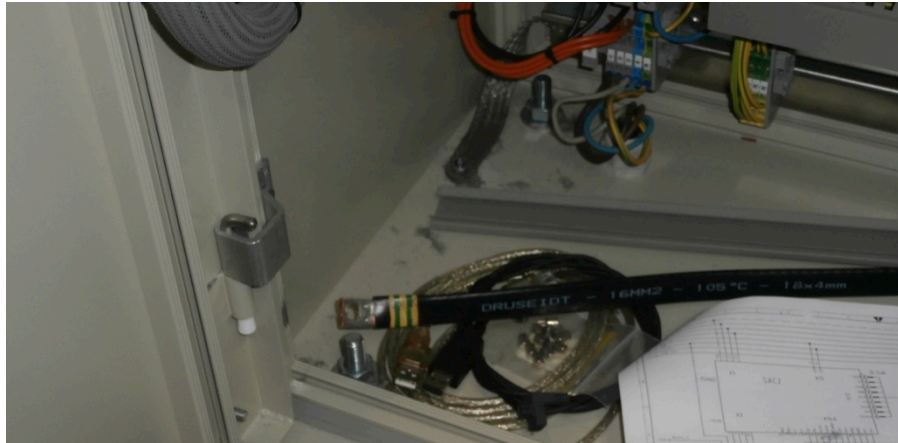
Hexapod / friction wheel

First Try:
Disconnect potential
equalisation cable to degrade
contact. Higher impedance of
electric loop?!

- Degrade of potential equalisation cable is not allowed!
Danger of electric shock.
- Metall (conducting) connection through mounting system between sample position and secondary spectrometer.
- Several ground wires within cables
