Recovery from the great earthquake in 2011 and a radioactive material leak incident at J-PARC in 2013

Kotaro BESSHO
Safety Division, J-PARC Center

- ◆ **The Great East Japan Earthquake on March 11, 2011.**
- ◆ **Radioactive material leak incident at the J-PARC Hadron Experimental Facility on May 23, 2013.**

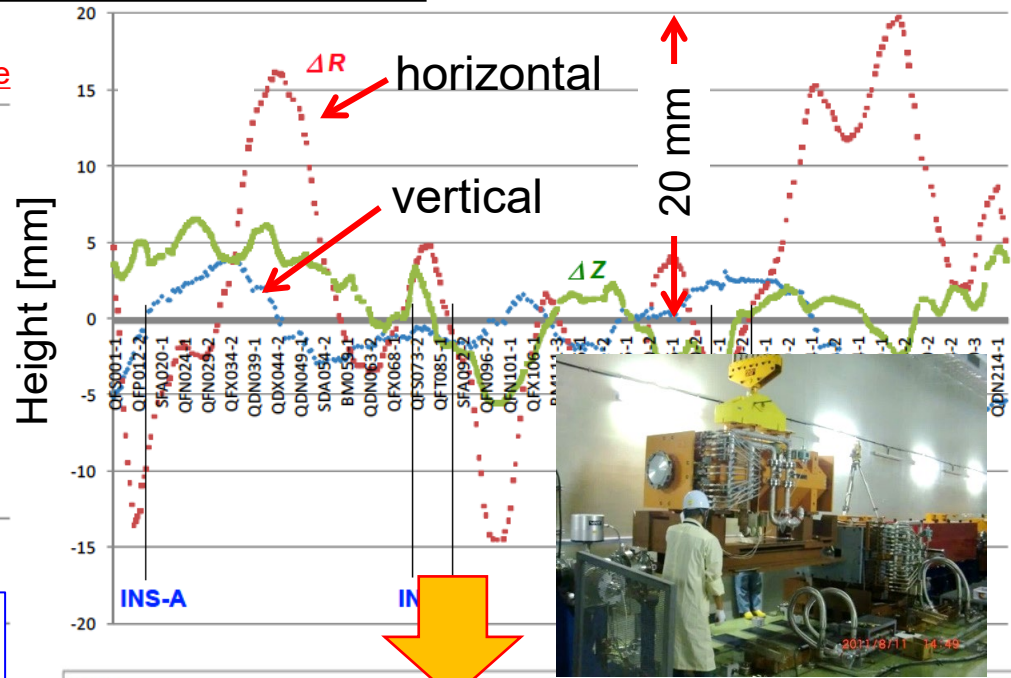
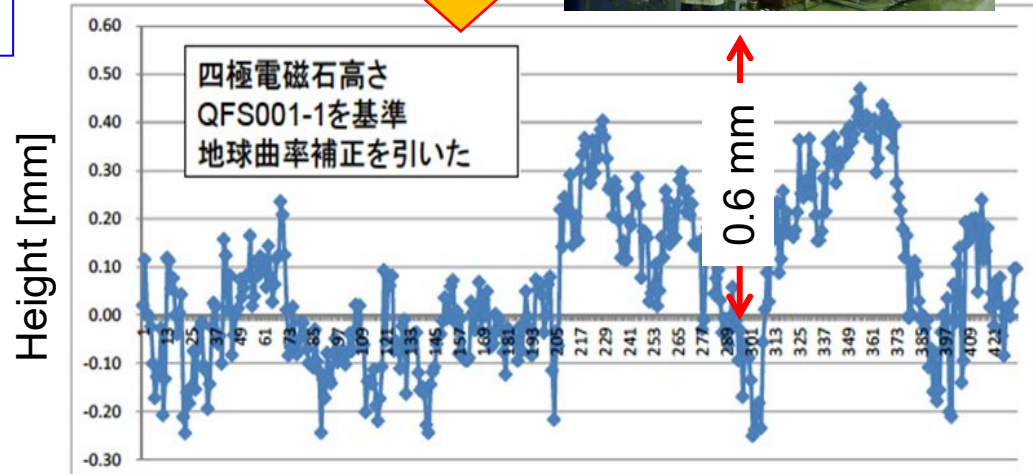
Misalignment of electromagnets at accelerator and beamline

misaligned ~ 20 mm (horizontal)
~ 8 mm (vertical)
for 400 electromagnets

Adjusted to
within 0.4 mm deviation

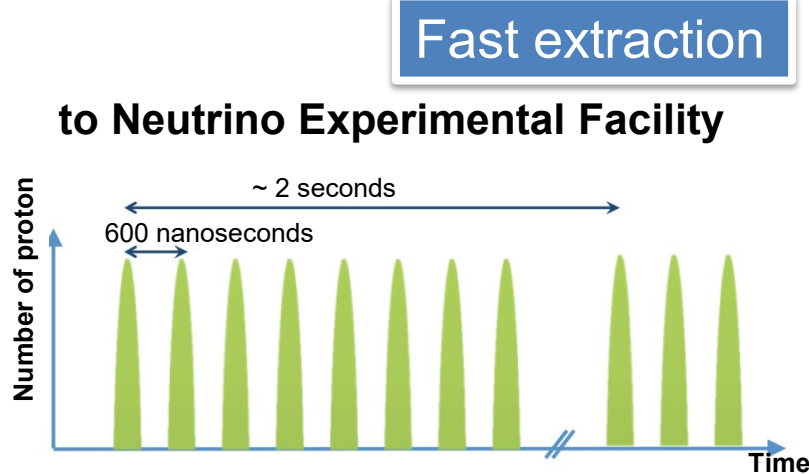
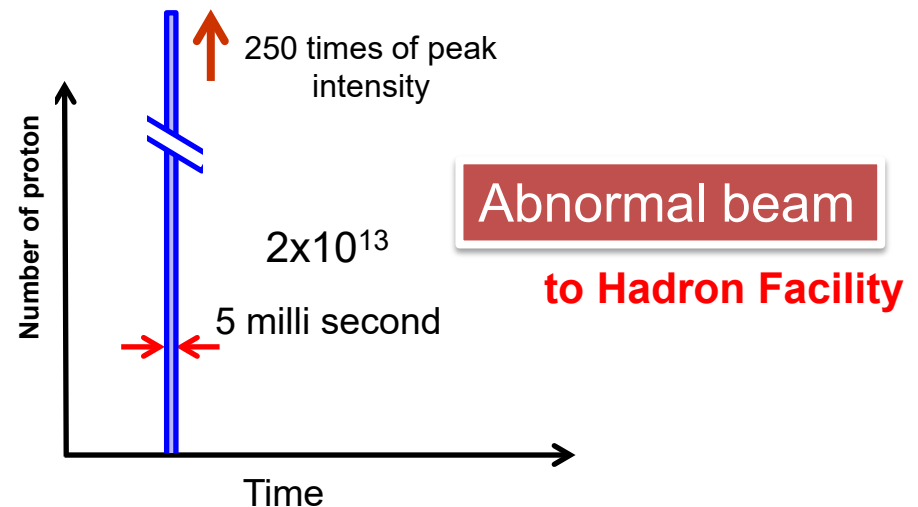
Malfunction of beam extraction system

An **abnormal proton beam** was injected to the gold target at **11:55 on May 23, 2013**.

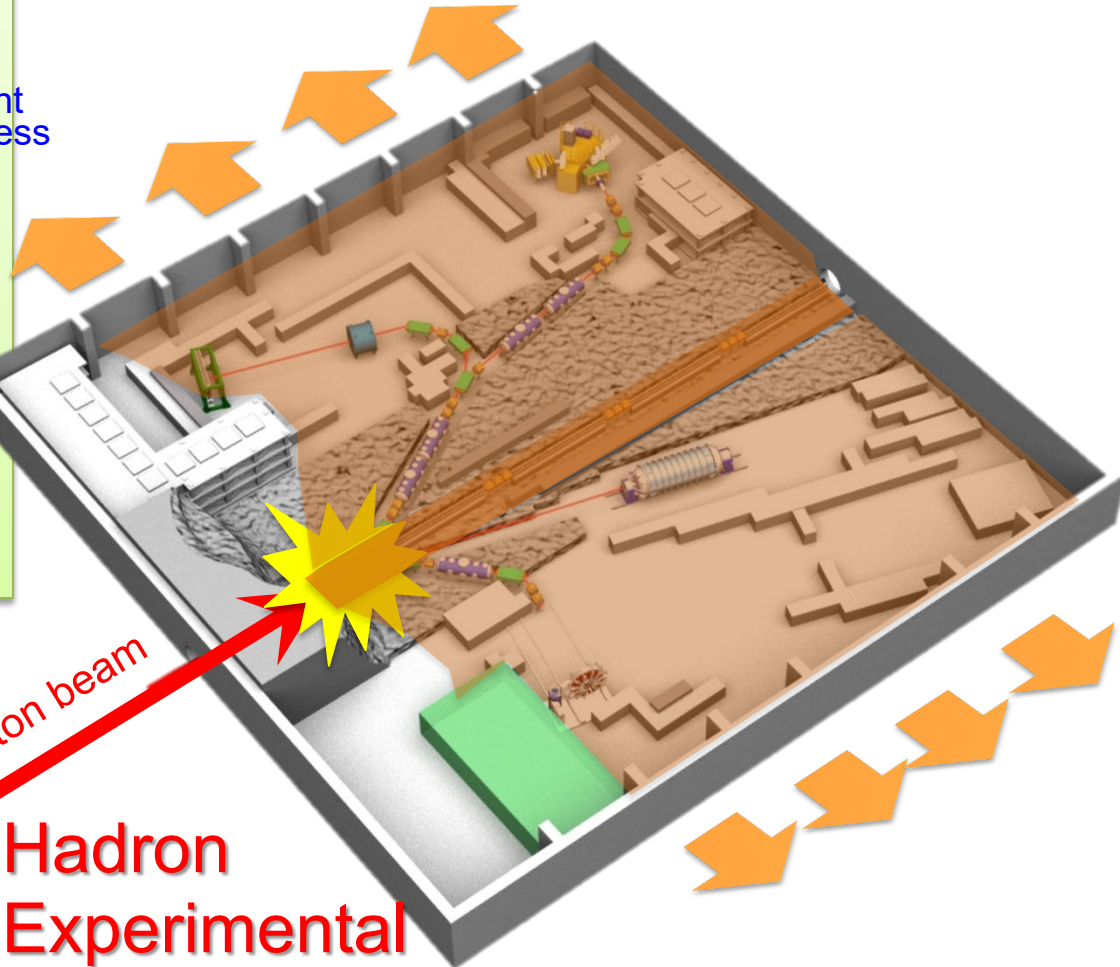
1. Abnormal beam hit the target

Heating of the Au target to melting

Release of radioactive material

=> inside target chamber *insufficient air-tightness*

2. Leak of the radioactive material

=> primary beamline *insufficient air-tightness*

Workers exposed to radioactivity.

3. Release of the radioactive material

=> **Outside of the controlled area**
through the ventilation fans

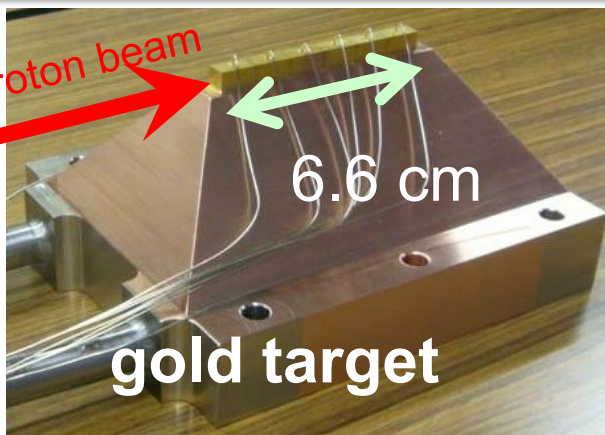
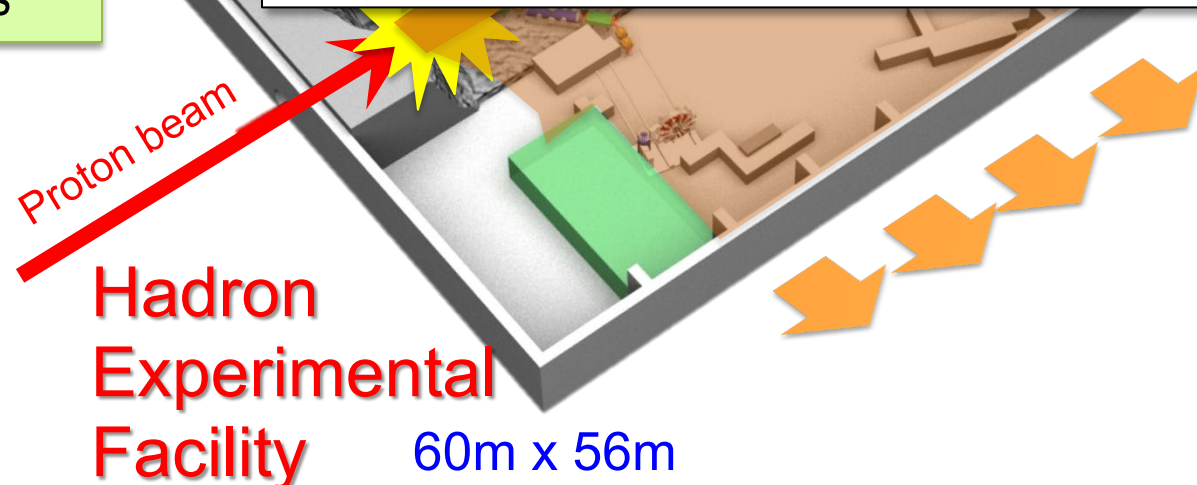
Radiation exposure on workers

: Max. 1.7 mSv

Integrated dose at the site boundary

: Max. 0.17 μ Sv

violate the regulations on radiation protection according to the law.

⇒ Radiation accident with notification required

Operation of all J-PARC facilities were stopped.

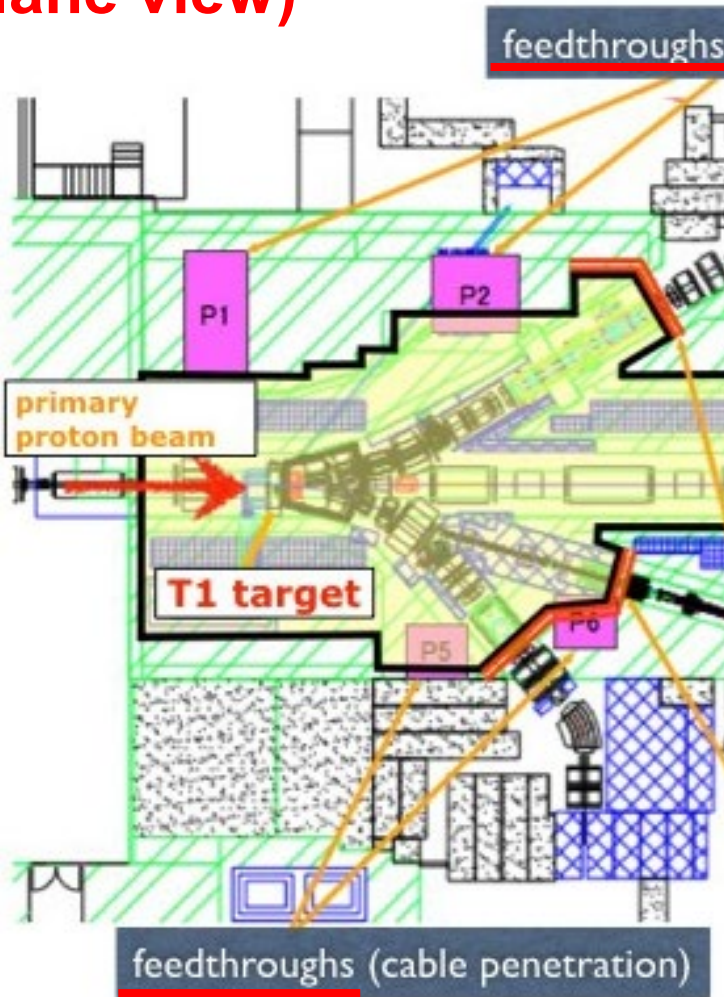
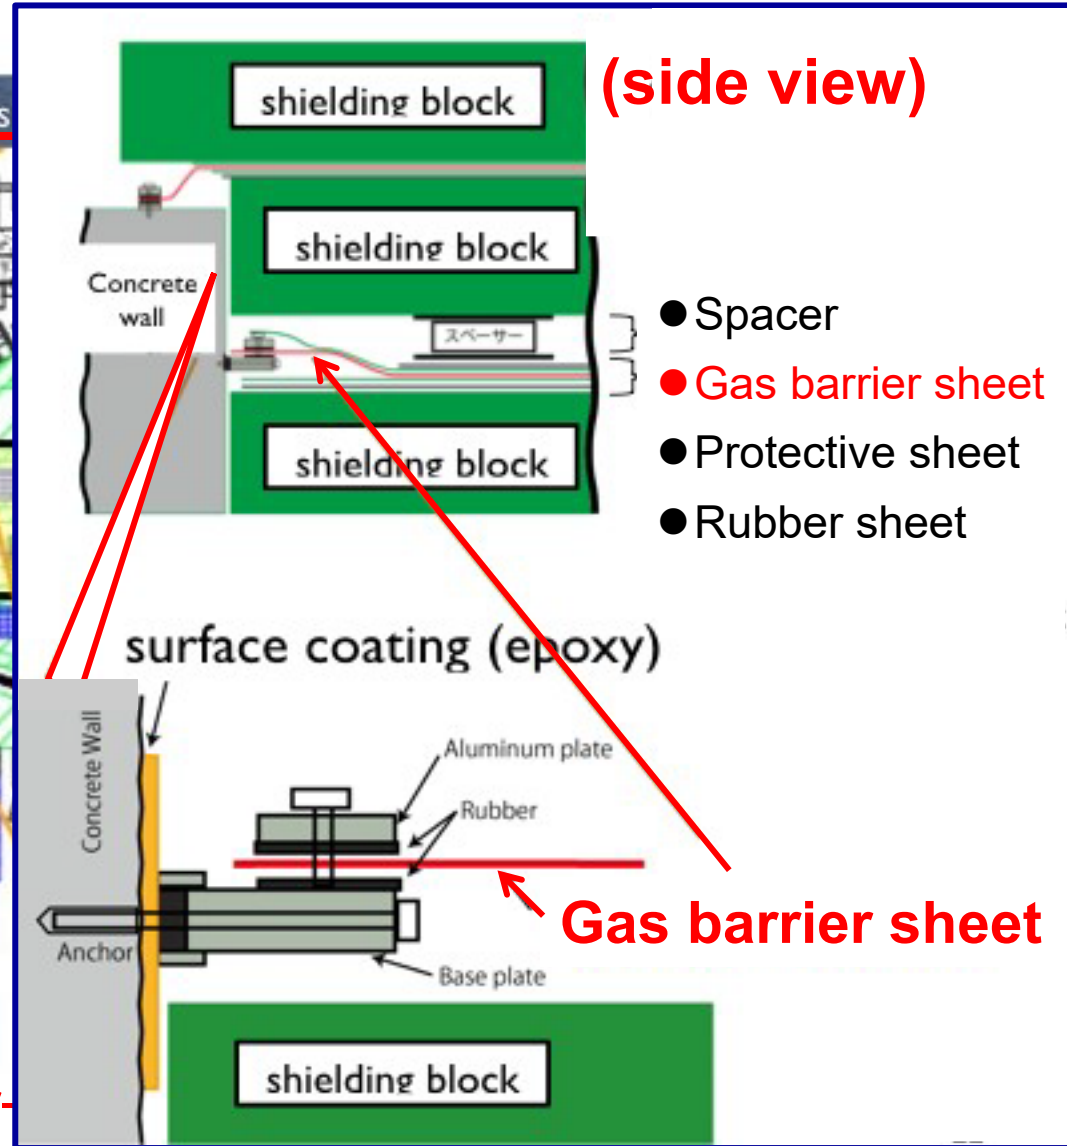
Improving Air-confinement of Primary Beamline

weak part in air-
